# Earthquakes and Irrigation in the Mexicali Valley

**Charles M. Burt, Ph.D., P.E., CID, CAIS**

**Abstract.** *On April 4, 2010, a 7.2 magnitude earthquake occurred within the Mexicali Valley approximately 30 miles south of the U.S. Border. Fields and canals within approximately 64,000 acres were severely damaged, with about 141,000 total acres damaged. This paper reports on the types of irrigation and drainage damage that occurred, the response by the governments and farmers, and the corrective efforts that have been and will be made on-farm and to the irrigation water distribution system that supplies the canals.*

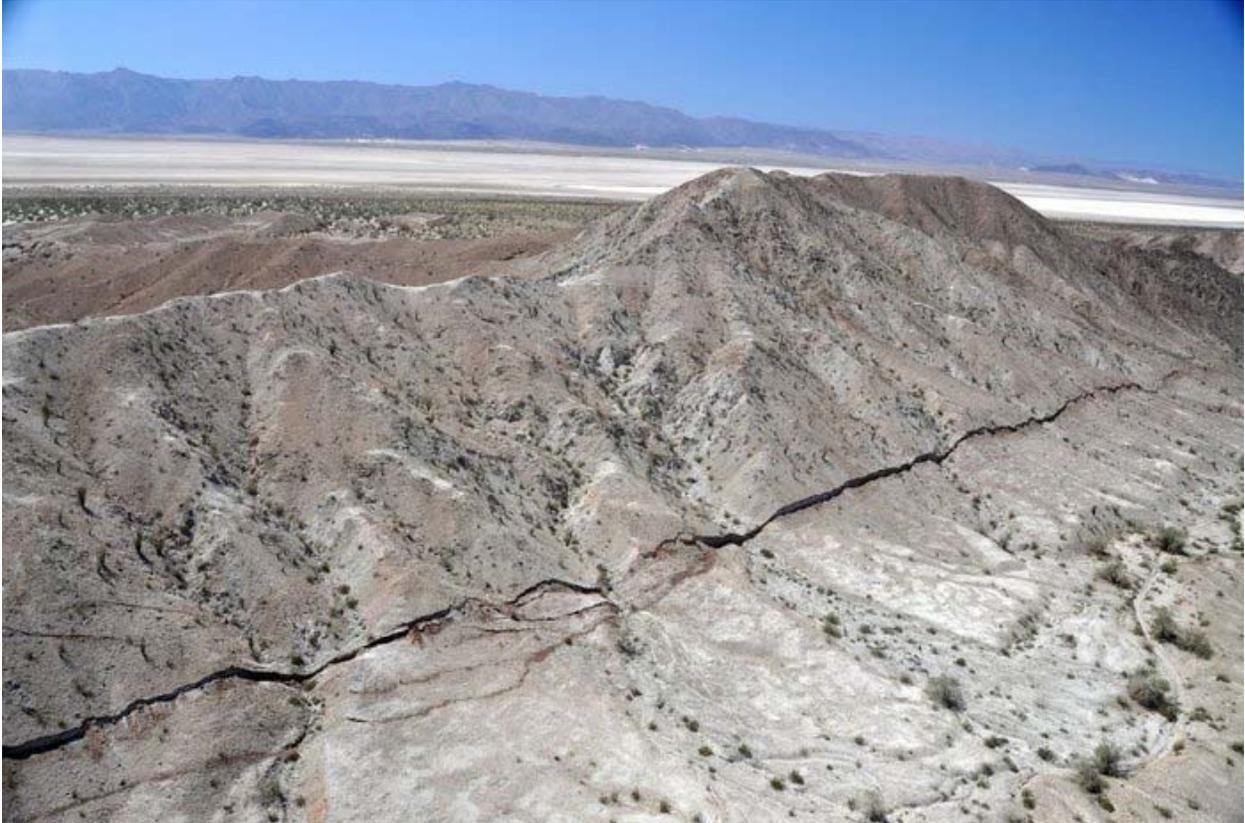
Figure 3. The quake pushed this mountain six feet into the air and 10 feet to the side in some places. The dark ribbon that runs through the mountain shows freshly exposed dirt. Photo by John Fletcher, Ensenada Center for Scientific Research and Higher Education (CISESE).

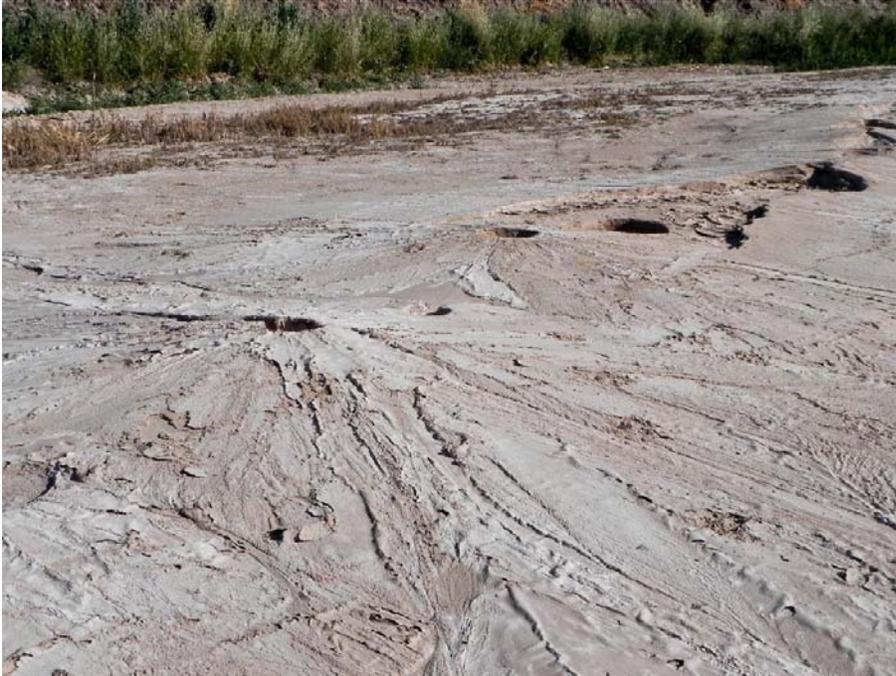
The earthquake was devastating to approximately 80,000 acres of irrigated land, with further damage on additional acreage (summarized later in this paper). The leveling of fields was completely destroyed; level fields became undulating and in many cases the slopes were reversed. The major drainage ditches for the lower part of the valley simply collapsed and filled in. Large canals cracked and heaved, and smaller lateral canals were often completely filled in with soil. Perhaps one of the most damaging and visually interesting aspects was the appearance of "volcanoes" of salty water that covered vast acreages of land, covering fields with sand and salty water. These were caused by liquefaction of the saturated subsoil.

Figure 4. "Volcanoes" of sand brought up by salty water onto fields.

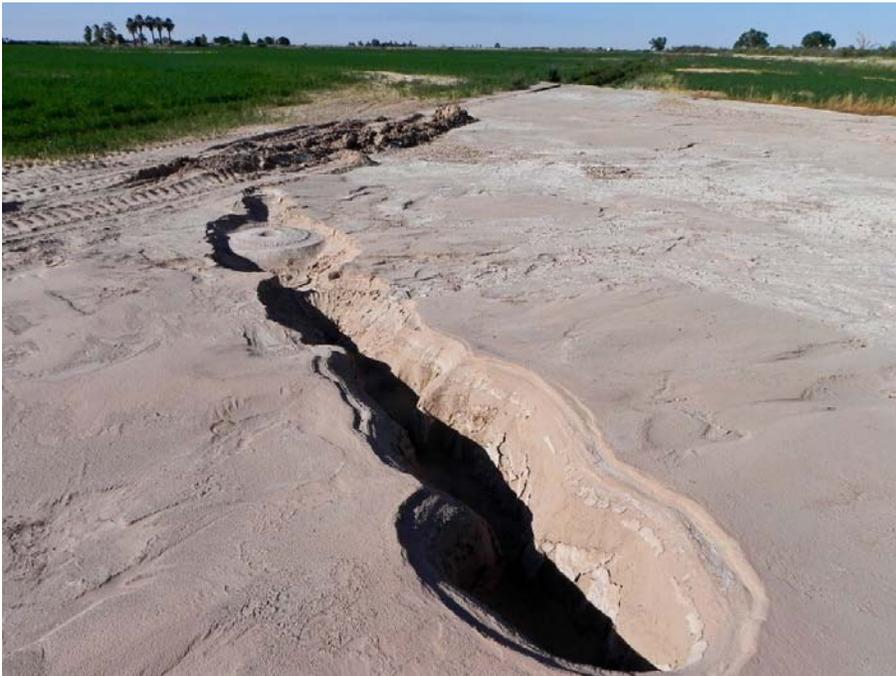
Figure 5. Typical covering of fields with liquefied subsurface soil that upwelled during the earthquake.

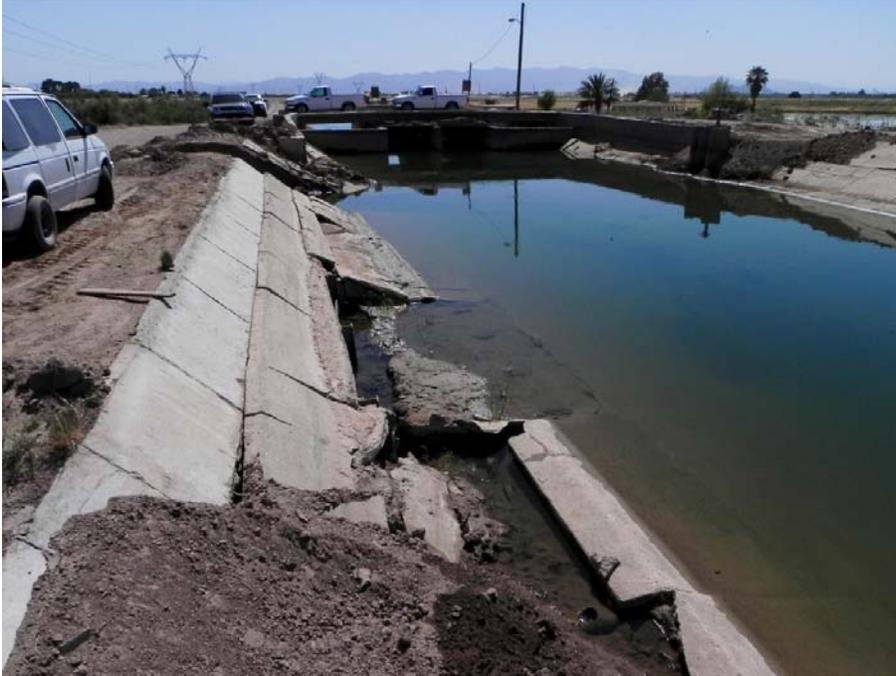
Figure 6. Damage to canal lining.

1. The canal banks were constructed of native materials, with a high silt percentage, that were not well compacted. From basic soil mechanics applied to slope stability problems, we know that this is undesirable.
2. There were high seepage losses from the canals prior to the earthquake due to cracked concrete lining. We concluded that in many areas, the soil under the concrete was saturated.
3. A high water table existed, indicating that the soil immediately under the base of the canal and its embankment were saturated.

1. The soil will be over-excavated, filled with compacted soil, and then the cross section for the new canal will be cut from the compacted soil.
2. The canal embankments, and the "footing" of the canal itself will be kept dry by preventing moisture from entering from above and below. The two solutions will be:

- a. The canal will be lined with a geomembrane to prevent seepage from "above". That geomembrane is equipped with a fuzzy material on its surface so that concrete will adhere to it. Concrete will be applied with a 3" thickness over the geomembrane. The concrete will provide mechanical protection from cleaning operations and other physical damage that might occur.

- b. A tile drain will be installed approximately 6' below the bottom of the canal, and to the side, to help lower the water table immediately under the canal. This will help minimize moisture from entering the embankment from below, and will possibly provide a more stable footing for the whole structure.

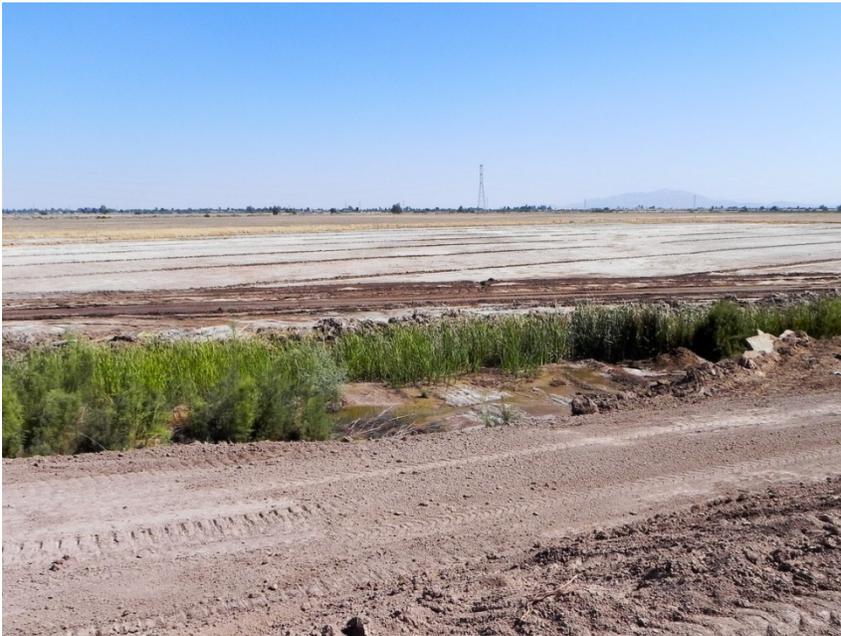
Figure 7. Field that was flooded by water from a damaged canal.

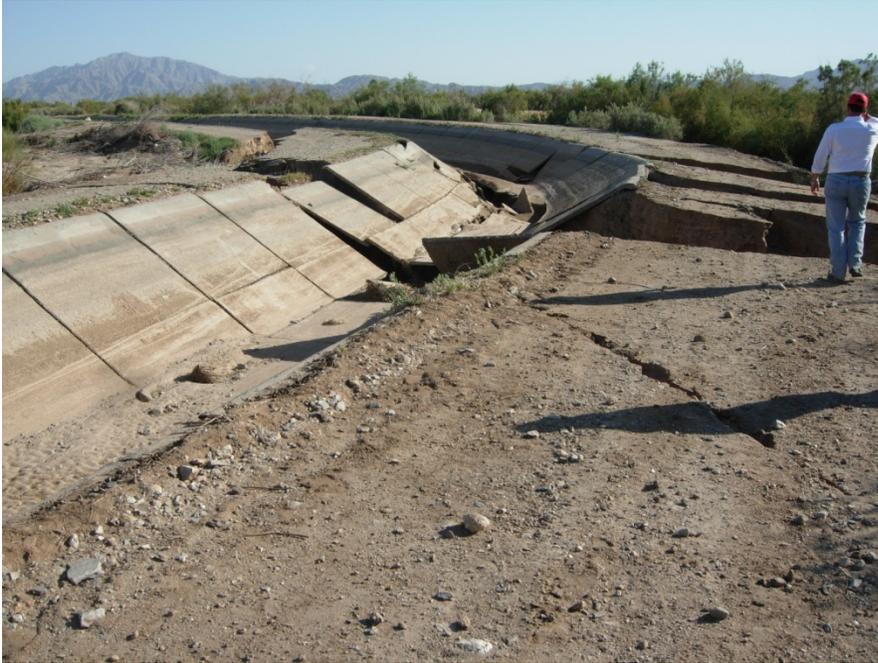
Figure 8. Damaged secondary canal.

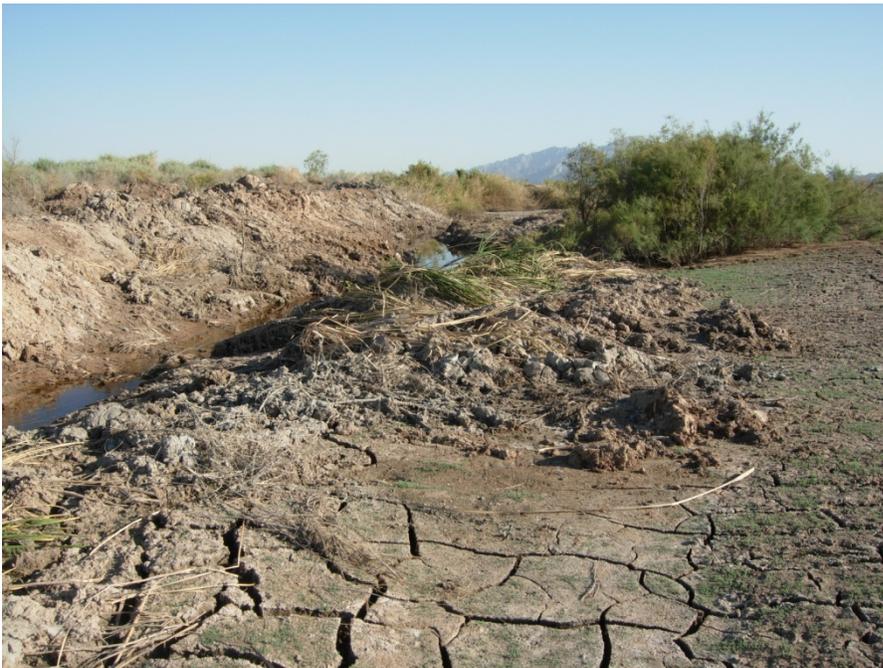
Figure 9. Drainage ditch that had collapsed and was partially excavated to provide limited remedial removal of salty water.

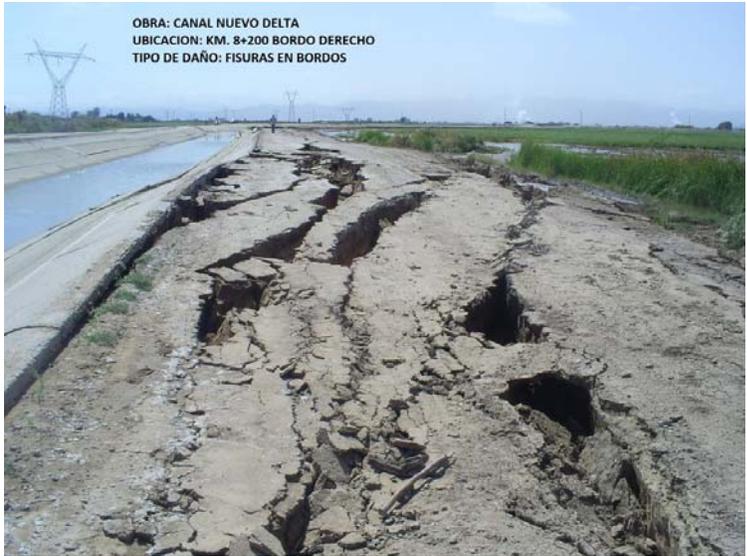
Figure 10. Fissures in the embankment road. Photo courtesy of CONAGUA.
