# EVALUATION OF POLYETHYLENE SUBSURFACE DRIP IRRIGATION DRIPLINES AFTER 26 YEARS OF SERVICE IN A CORN FIELD IN NORTHWESTERN KANSAS

**Adriana Velasquez, Mark Jablonka, Freddie Lamm, Eddy Garcia-Meitin**  
The Dow Chemical Company / KSU Northwest Research Extension Center

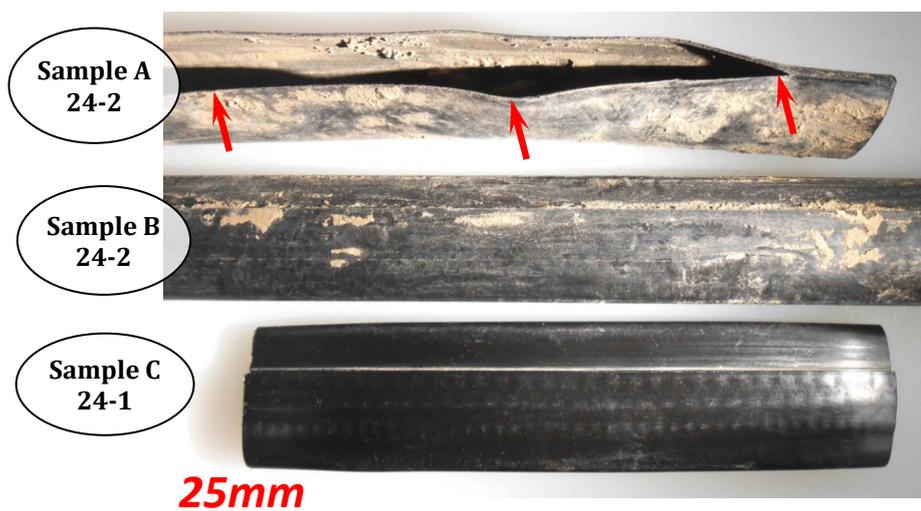
**Figure 2. As received dripline samples.**

The failed dripline was coated with dirt on both interior and exterior surfaces as received. The presence of dirt on the inside of the dripline was likely caused by either the dripline failing or being cut and removed from the field. Figure 2 is a photo of pieces of the materials received. Sample A is a portion of the failed dripline that was split. A sharp linear failure occurred along one of the two edge creases indicated by the red arrows in the photo. This failure is a machine direction split in the dripline. Sample B is a portion of the failed dripline that did not contain a failure and sample C is the control dripline which was manufactured back in 1989 but was never put in service, instead it was stored for 26 years.

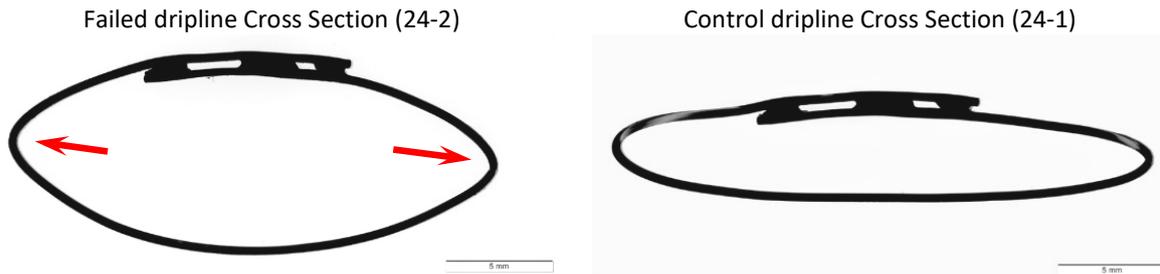
**Figure 5. Cross sections of failed and control dripline samples.**

Although dripline failures occurred along a crease the overall dripline remained pliable and visual evidence of degradation did not exist<sup>12</sup>. Figure 5 includes a cross section of the failed dripline along with a cross section of the control dripline used, with the red arrow indicating where the dripline failed. This area is where the dripline is creased as it is rolled onto the spool after being fabricated. It remains on the spool in a collapsed state until it is installed in the field.

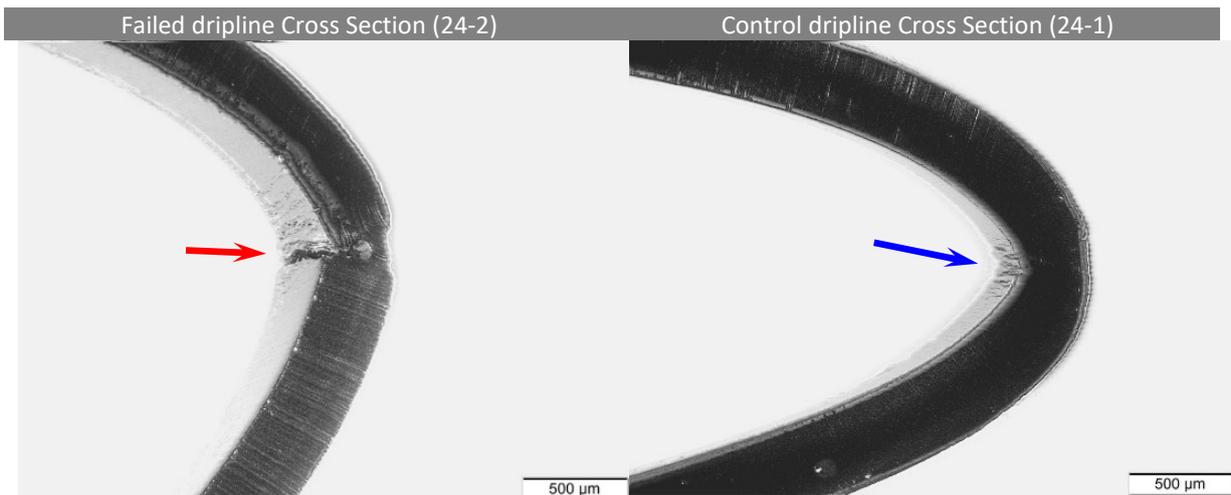
**Figure 6. Cross sectional optical microscopy images of failure region in both Failed (24-2) and Control (24-1) dripline Specimens.**

Figure 6 contains dripline cross sectional optical microscopy images taken at the failure region of the dripline. Surface striations were present along the inner surface of a control dripline which followed edge creases (blue arrow). These inner surface striations acted as crack initiation sites for the failures as shown by the internal cracks (red arrows) in the failed in-service dripline.

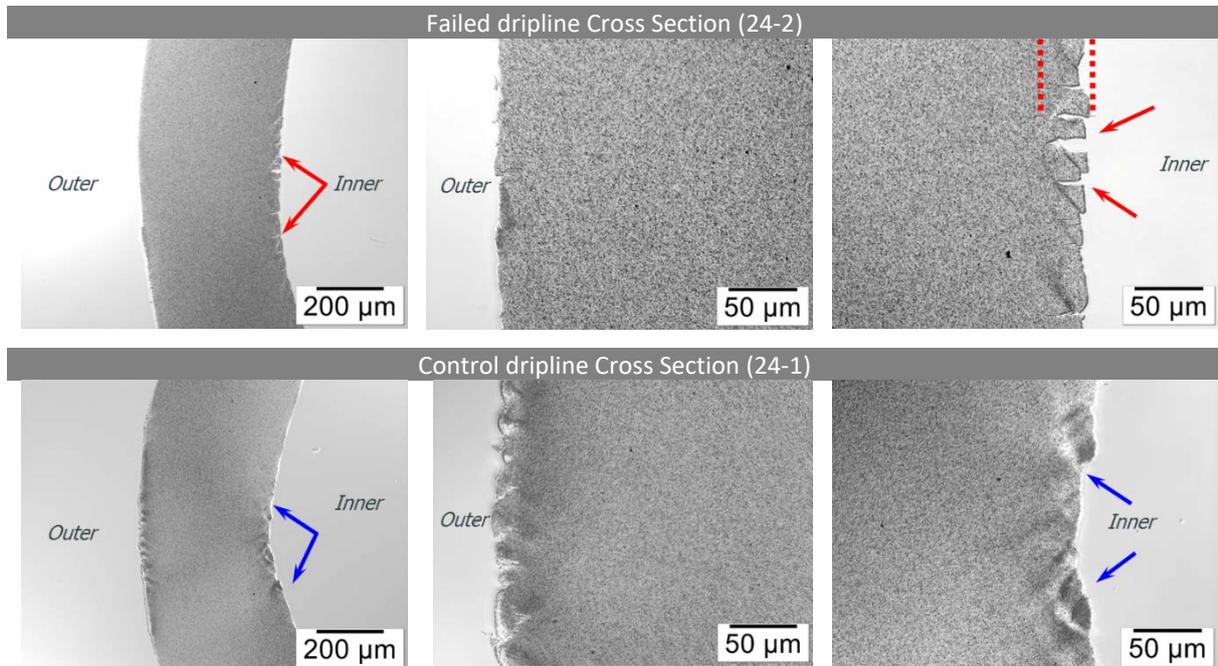
**Figure 7. Cross sectional optical microscopy images of failure region in both failed (24-2) and control (24-1) dripline specimens**

Figure 7 contains higher magnification views of the cross section of the failure region of both the failed and control driplines. Surface striations were present along the inner surface of a control dripline which followed the edge crease (blue arrows). Outer surface deformations

were also observed in the control dripline. Sharp internal cracks (red arrows) were present on the inside surface of the failed dripline in the crease region, but not on the outside surface of the dripline. Crack penetration was approximately 40um along the inner dripline surface.

A review of cross section images shown in Figure 7 and Figure 8 indicate remarkable level of carbon black dispersion and homogeneity by today's standards in dripline material used.

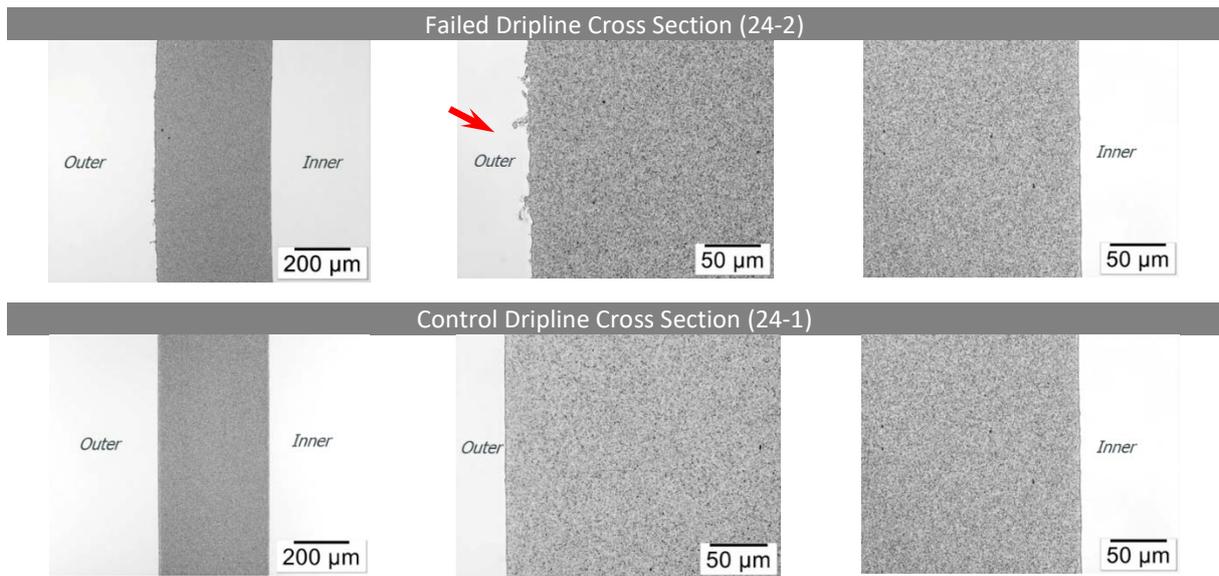
**Figure 8. Cross sectional optical microscopy images of flat (non-failure) region in both failed (24-2) and control (24-1) dripline specimens**

Figure 8 contains cross sectional images of the flat region of both failed and control driplines. The internal surface of both the failed and control driplines in areas away from the crease were absent of any striations, cracks or defects, suggesting the strain in the crease area coupled with exposure to the liquid medium pumped through the dripline over the years led to the failure of the dripline in the failed dripline sample which is expected. Evidence of dripline degradation or cracking was not observed in areas away from the crease. Prior studies have shown an increase in the rate of degradation of polyethylene when a constant strain has been applied.<sup>v</sup> Slight abrasion was observed (indicated by red arrow in Figure 8) along the outer surface of the failed dripline, but is not present on the inner surface of the failed dripline. This abrasion likely occurred during the installation of the dripline because it is not present in the control dripline. There was no evidence of failures initiating from the slightly abraded surface of the failed dripline. This abrasion must have occurred during installation or normal use over time.

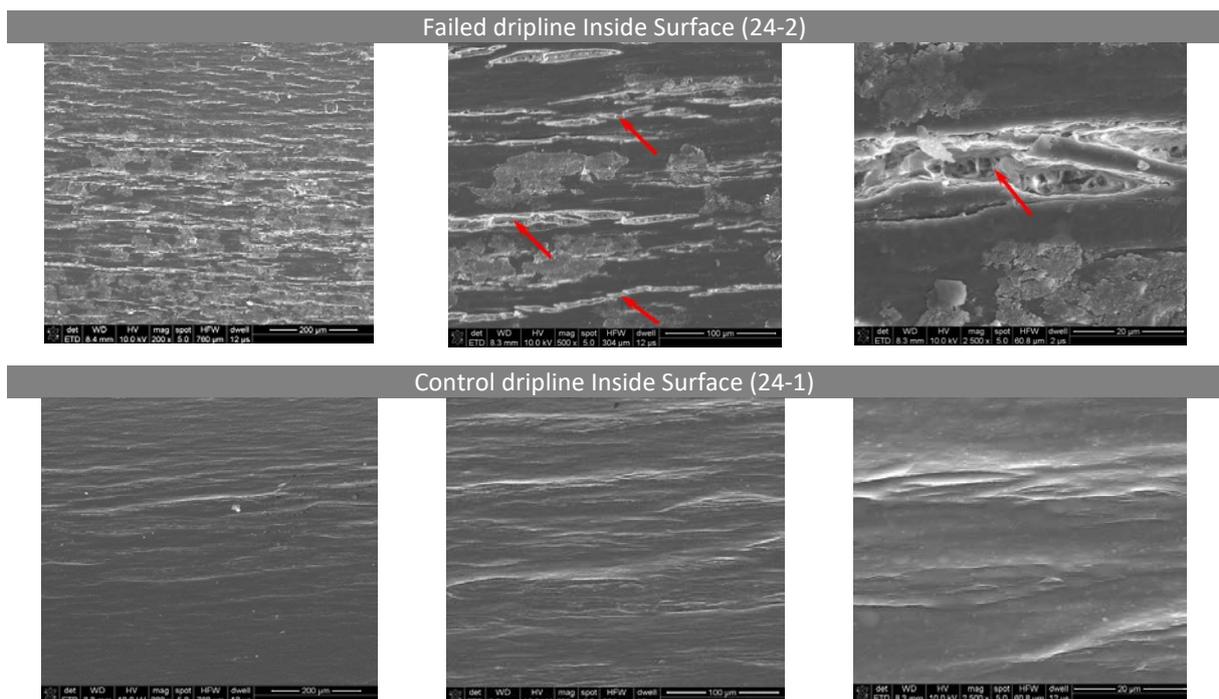
**Figure 9. SEM Images of Inner Surface of Crease Region in both Failed and Control Dripline Specimens.**

An evaluation of the inner dripline surfaces showed parallel striations were present along edge creases, as shown in optical cross sections. Figure 9 contains scanning electron microscope (SEM) images of the inner surface of the crease region in the failed and control dripline specimens. Surface cracks were not observed along creases in the control dripline. Sharp parallel cracks (red arrows) were present along the creases of the failed dripline.

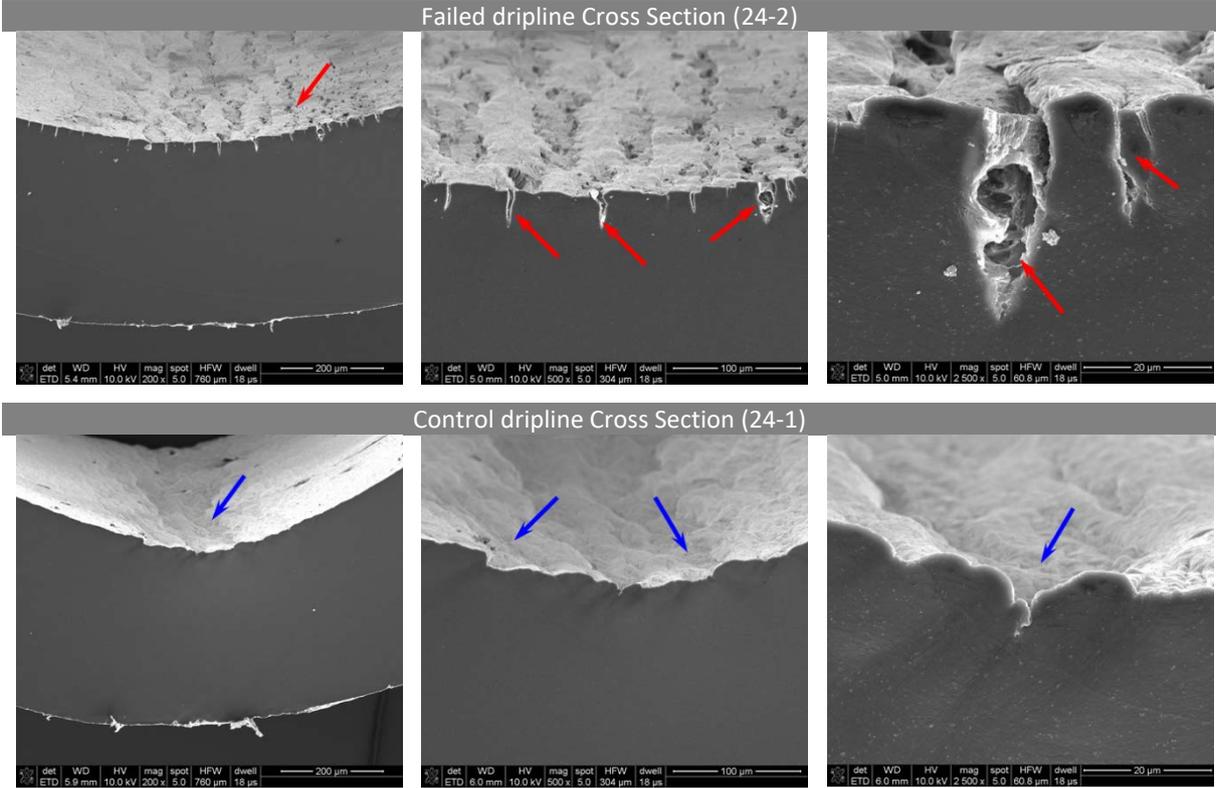
**Figure 10. SEM cross section images of crease region.**

Comparison of the inner surface of the crease region of the dripline using SEM shows the surface striations present in the control driplines, shown in Figure 10 and highlighted with blue arrows. The cracks on the inner surface crease region are also shown in the failed dripline (red arrows), with cracks penetrating approximately 40um into the wall of the dripline.

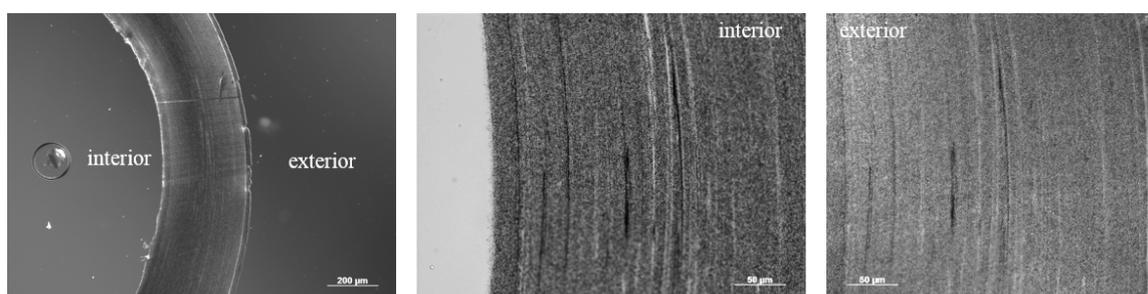
**Figure 12. Cross sectional optical microscopy images of Dripline made in 2017 with 100% Dow FINGERPRINT™ Resin**

Analysis of a dripline manufactured in 2017 with Dow's FINGERPRINT™ resin was done. The results are shown in Figure 12 below. The pictures show that the dripline does not have striations on the crease, there is no evidence of manufacturing deficiencies. Therefore the striations observed on the 26 year old dripline which initiated the failure likely appeared over time due to the depletion of the AO and localized compressive stress in the fold area during its lifetime. That is why the control tape also presented the striations, but didn't fail due to the fact that was not in use. This is the same issue any collapsible/folded tape would have.
