Recycled Water for Landscapes

in the Middle East

by Stephen W. Smith¹ and J.D. Leonard²

Aqua Engineering, Inc., Fort Collins, Colorado

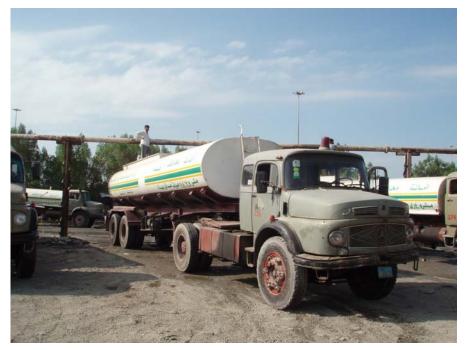
Figure 1. Tanker trucks are filled at the sewage treatment plant and recycled water is hauled to subterranean tanks throughout the community. Water is used for landscape irrigation.

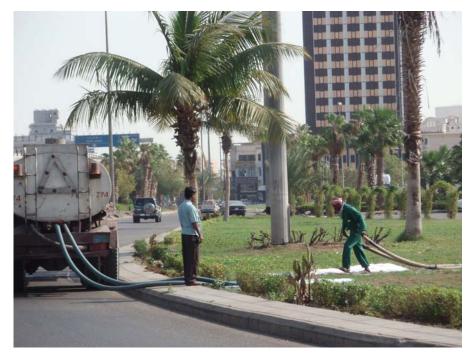
Figure 2. Some landscapes are surface or flood irrigated directly from tanker trucks as shown here.

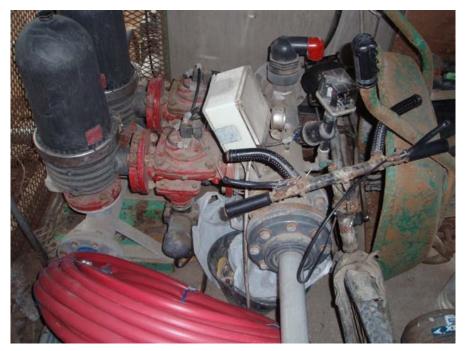
Figure 3. Some pump enclosures were also used for storage of other landscape maintenance equipment as well as personal items of workers.

Centrifugal pumps with a foot valve on the intake are used to pressurize the system. Element filters are located downstream of the pump. In a few cases, a water meter is found downstream of the pump station.

See Figures 3, 4, 5, 11, and 15.

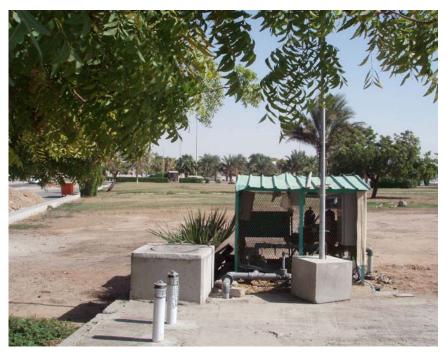
Figure 4. Pumps and filters are housed in expanded metal enclosures with a metal roof. The concrete tank holding 100 cubic meters of recycled water can be seen in the foreground. This site is centrally controlled and the antenna for the control system is set in the concrete block seen in the foreground.

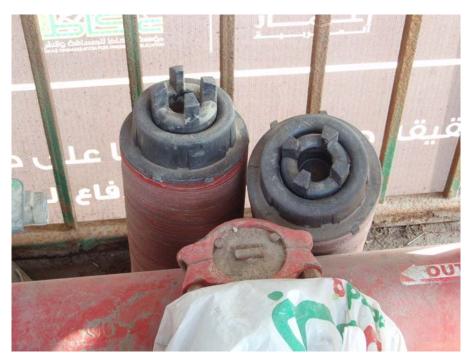
When filter elements become clogged, the landscape maintenance workers may remove the element and leave it out of the filter housing so that a greater flow and pressure can be attained. Irrigation equipment then is likely to become clogged and emission devices are then often removed by maintenance workers as a response. In many cases the irrigation lateral has become, in effect, a means of flood irrigating medians or other landscaped areas that are bordered by a curb which contains the water inside the landscaped areas.

The issue of one problem leading to another and hence another has a cascading effect. A root cause of these problems is water quality. If recycled water was of greater quality and a predictable quality, then some core maintenance issues could be resolved. Worker response can most likely be resolved by implementing training programs.

Figure 5. Filter elements are often removed by workers to increase flow and pressure downstream of the pump station. This, of course, aggravates plugging of emitters and orifices in other water emission equipment.

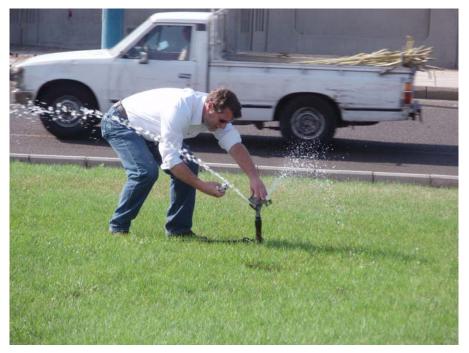
Figure 6. Pressures were measured to document dynamic pressures in the irrigation system. Low pressures were sometimes due to multiple laterals opened manually and simultaneously, thereby causing the pump to run out on the pump curve and produce inadequate pressures.

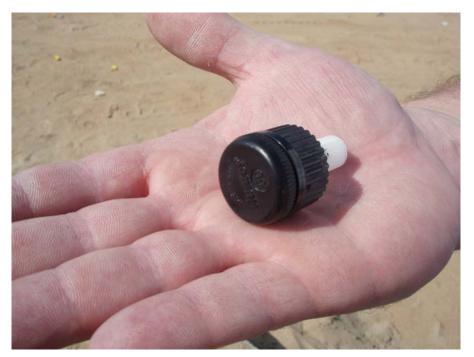
Examples of sprinkler, drip, and bubbler irrigation can all be found depending on the age of the irrigation system and who designed the system. Bubbler irrigation is most prevalent and this

would likely be related to the greater orifice sizes found in bubbler irrigation and therefore the greater reliability of bubbler irrigation systems. Most bubblers were not pressure compensating.

Figure 7. Bubbler irrigation is prevalent. Some bubblers are imported from the U.S. but bubblers are also manufactured in the Middle East.

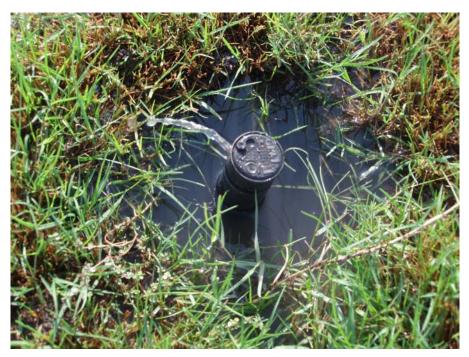
Figure 8. This operating sprinkler is clearly operating well below minimum acceptable pressures.

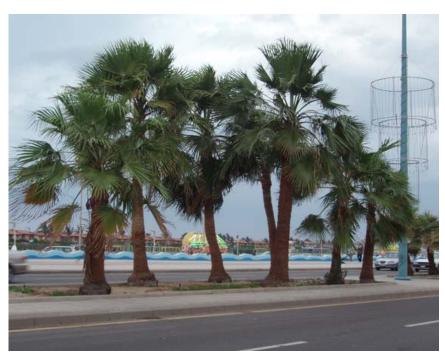
Figure 10. Palm trees in roadway medians dominate the landscape but often with an understory of groundcover or flowers.

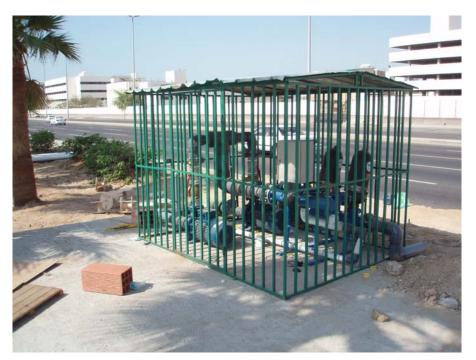
Figure11. The pump, filter, and control system housed in this enclosure are exemplary of the newest construction.

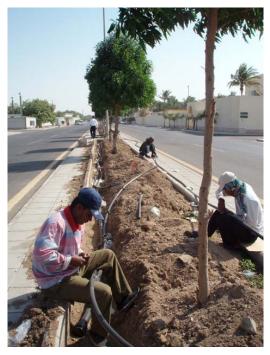
Figure 12. Workers shown here are installing bubblers that will be used to irrigation trees as well as understory groundcover.

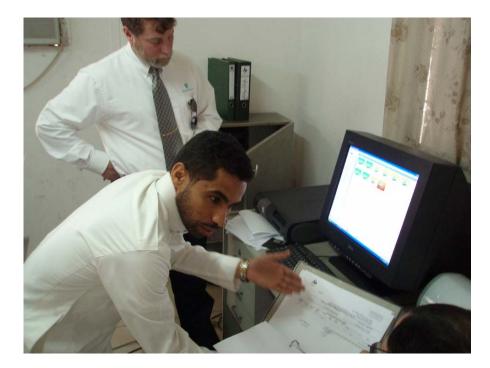
Other sites are centrally controlled and the storage tank water surface elevation is monitored. See Figure 13. A weather station is integrated with the central control.

Figure 13. A portion of the landscape irrigation systems in the City of Jeddah are controlled using a central control system tied directly with a local weather station to monitor day-to-day evapotranspiration rates.

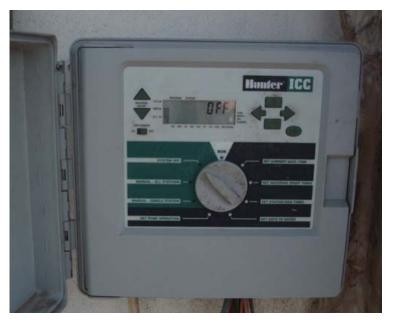
Independent irrigation controllers are in use although some are set in the "off" position and the system is operated manually by the landscape maintenance workers assigned to that site.

Figure 14. This irrigation controller is an independent controller not compatible with the central control system. Only a small portion of the 400 landscape irrigation sites are on the central system.

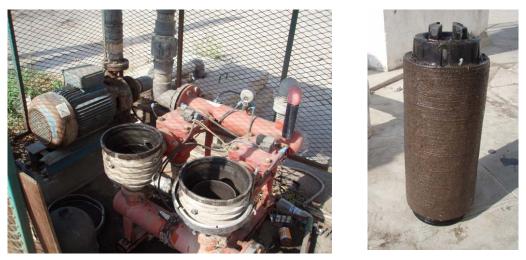
Figure 15. In the photo on the left above, the filters were disassembled to show that no filter elements were installed at the time of this site visit. In the photo on the right, the clogged filter element can be seen. This filter element was sitting off to the side -- uncleaned and unused.

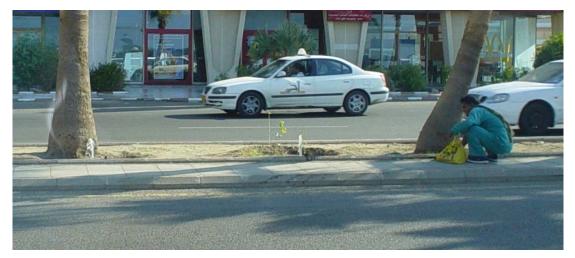
Figure 16 shows an example of maintenance worker response in the field. The bubblers have been removed and placed to the side so that a greater flow of water can be attained. These bubblers will likely be replaced after the median is sufficiently irrigated in the workers' view. This system is being controlled manually at the remote control valve. This is another example of cascading problems that can be corrected.

Figure 16. The "fountains" in the median are the result of the maintenance crew removing the bubblers from the risers during sprinkler operation. The bubblers are the black caps to the left of the fountains. It is assumed that the caps are then replaced at the end of the irrigation cycle, although several areas were observed with missing bubblers. This adapted approach to bubbler irrigation is the result of "cascading" operation and maintenance issues.
