Irrigation Construction Management:

Capital Projects Irrigation Design and Installation Quality Control

Examples of Project Installation Problems: ICA Indoor Practice Facility (OPF Phase 1), Project 2498

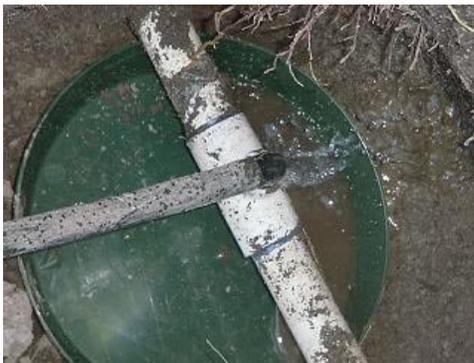
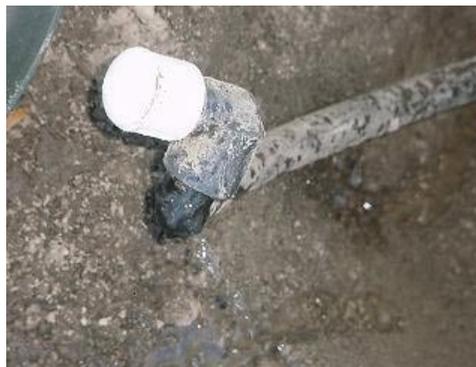
Figure 1

The following leakage problem was discovered during the spring 2001 system activation and pre-audit. Figures 1 and 2 show leakage from both upstream and downstream connections between fittings and polyethylene piping. The polyethylene piping was defective – pitted and incapable of making a seal. The piping also exceeded specified depths and run lengths. Furthermore, the upstream connection lacked a Marlex ell to give 3-way directional control. The resulting "bend" stress and the lack of Teflon tape further aggravated already poor connections, further contributing to leakage. Each bad swing assembly resulted in about 50 ounces of leakage per minute. Note that the worst leakage from the upstream connections was far below the root zones of the planting, thus, this water, more than half of the total leakage, was completely wasted. Note that this deep leakage was not obvious. Downstream swing assembly leaks can often result in undermining the stability, and thus pitch and elevation, of sprinkler heads over time, which typically results in high maintenance costs to "true" numerous heads during spring system activation and pre-audits. Given a Northwest irrigation season (6 months), had the leaks not been corrected, the collective leaks, considering an irrigation schedule adjusted monthly for ET, would have amounted to 317.34 hundreds of cubic feet (CCF), and at the commercial peak rate of \$2.75/CCF, would have equaled \$872.69 per year. Through the 2002 irrigation season, 772.66 CCF would have been lost, amounting to \$2,124.82.⁵

Yr	Tot Adj min/yr	Leakage (50 oz/min)(128 heads)	Total leakage oz/yr (adj min/yr)(leakage)	Tot leak gal/yr (tot oz/128oz)	Tot leakage CCF/yr (gal).(001337CCF/gal)
'02	4,747	6,400	30,380,800	237,350	317.34
'01	4,747	6,400	30,380,800	237,350	317.34
00	2,064*	6,400	13,209,600	103,200	137.98
Water loss due to leakage from '00 through '02 if problem not corrected					772.66 CCF
Water loss in dollars @ peak rate of \$2.75/CCF					\$ 2,124.82**

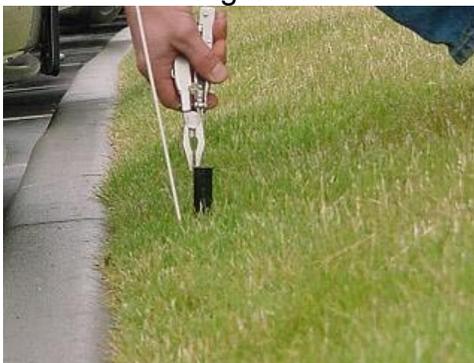
Figure 3 shows a sprinkler head that was not installed per spec. The spec notes that heads must be installed at a grade perpendicular to the average slope. This head, despite the nozzle's 23-degree trajectory, cannot achieve head-to-head coverage with its not-in-picture counterpart to the right. This resulted in a lack of coverage/poor distribution uniformity – areas that were too wet and too dry, resulting in unhealthy and unsightly turf grass.

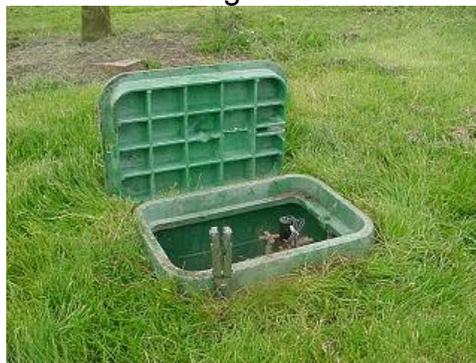
Figure 4 shows an improperly installed valve box. The box is above grade, and would likely impede and/or get damaged by mowing. Note the valve was installed too high, and that reinforcing cells on the underside of the lid have been cut out to make room for it, thus, weakening the lid, as well as putting pressure on the solenoid as in the case of equipment driven over the box.

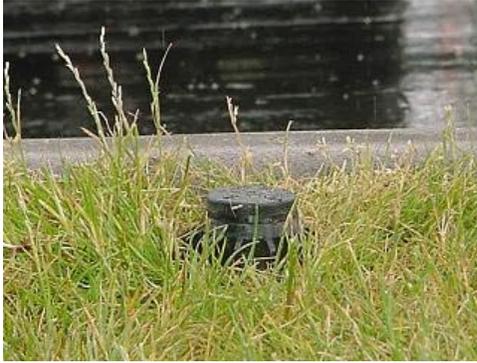
Figure 5 shows a rotary sprinkler head installed incorrectly – it is too high and too close to the extruded curb. It should be flush with finish grade with placement starting at 1¼ to 1½-inches perpendicular from the hardscape. This is a likely candidate for mowing and/or edging damage.

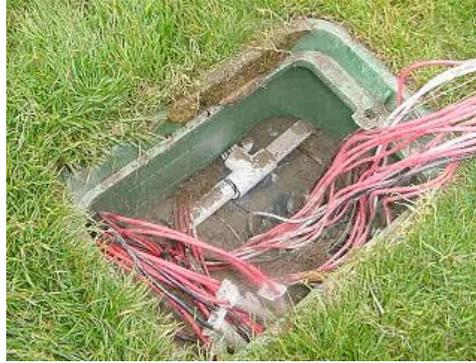
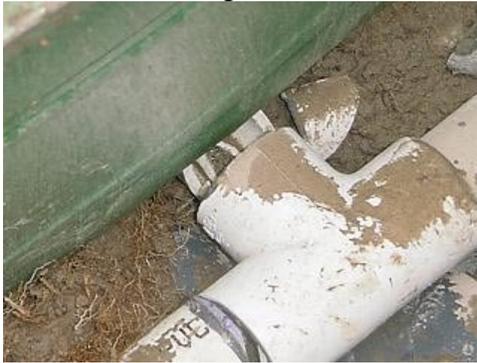
Figure 6 shows another improperly installed valve box. Note that it's resting on a lateral pipe. Figure 7 shows a close-up of this lateral pipe – already broken, probably from pedestrian/equipment weight. All piping should have ample clearance between valve boxes. Not completely visible is a mainline directly under the lateral, or "stacked," which is a spec violation due to the difficulty in making future maintenance repairs. Pipes should be installed side by side with adequate clearance between.

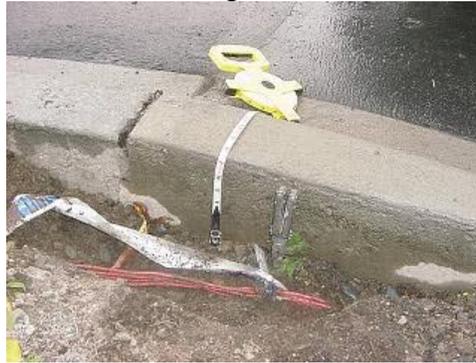
Figure 8 shows signal wiring above the specified depth of 18-inches (mainline depth). Shallow wiring is vulnerable to landscape and utility work. Note that the metallic warning tape was installed by UW Irrigation, not the contractor, as a post-installation damage countermeasure.
