## **WATER MANAGEMENT IMPROVEMENTS IN CACHE VALLEY IRRIGATION CANALS**

### **Abstract**

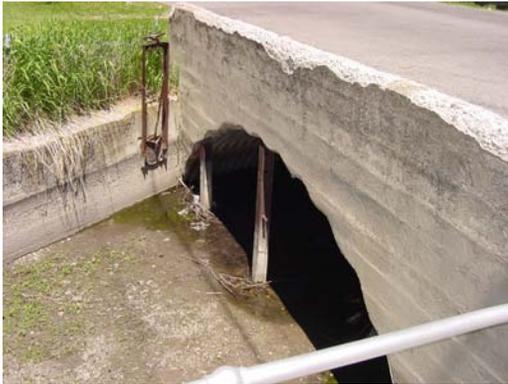
**Fig. 2.** Culvert inlet and a deteriorated outlet gate (Northwest Field canal)

- Periodical removal of weed growth;
- Clearance of debris at the screens;
- Lubrication of outlet gates and head gates;
- Repair of flow measurement structures (where necessary);
- Removal of sediment from the canals; and,
- Repair of side walls damaged by trees growing near the canals.

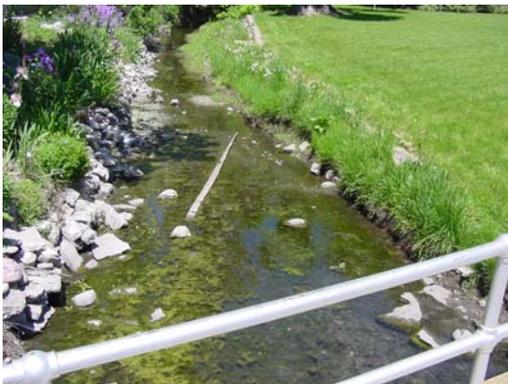
**Fig. 4.** Much weed growth and algae and narrow canal width (Logan Northwest Field canal)

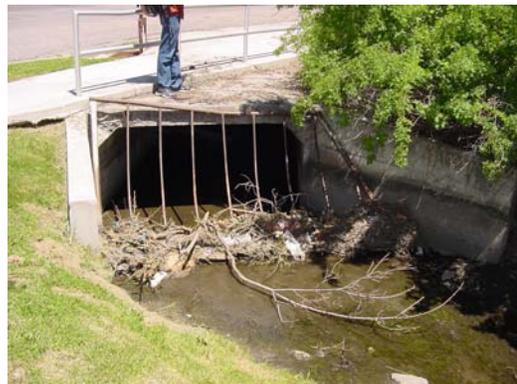
**Fig. 5.** Upstream side of a bridge where debris has collected (Logan Northwest Field canal)

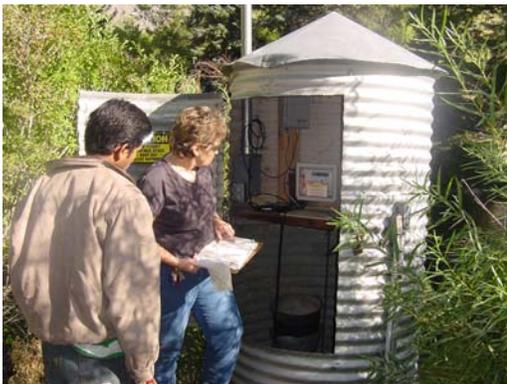
**Fig 7.** Colleen Gnehm with one of the authors, checking a water level recorder

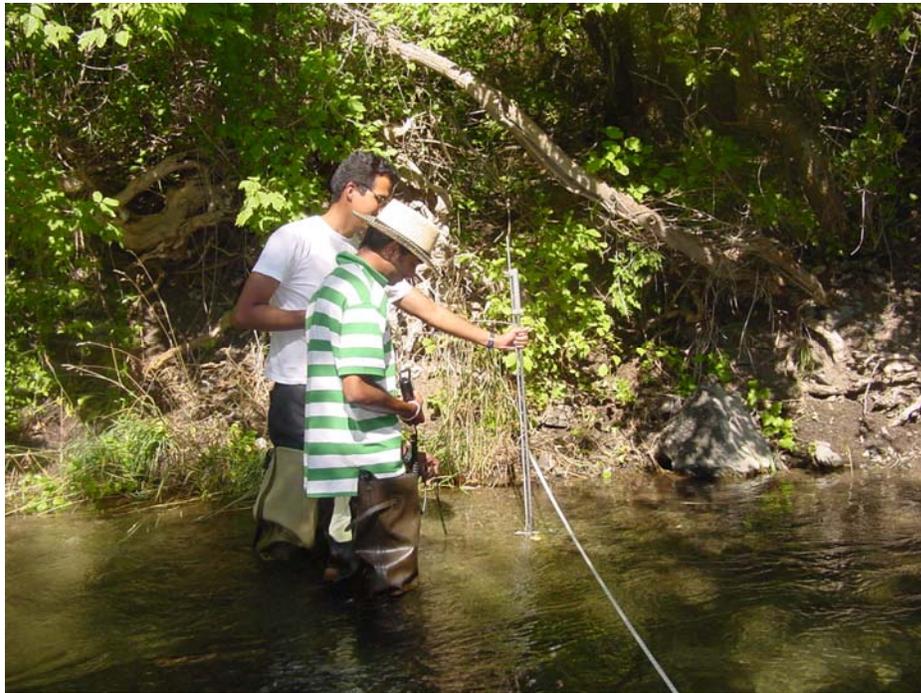
**Fig. 9.** Current metering in a canal to determine seepage losses

- The Logan North Field canal, which is also called the “Twin Canals,” has been found to have a seepage loss of 7.7%. It showed a loss of 1.82 cfs from beginning of the canal where the flow rate was 23.7 cfs for a length of 1,450 ft.
- The Smithfield-Hyde Park canal was found to have a seepage loss of 6.5%. It showed a loss of 3.3 cfs from beginning of the canal where the flow rate was measured 50.5 cfs for a length of 1,440 ft.
- The Southwest Field canal has been found to have a seepage loss of 17%. The total flow at the upstream was found to be 2.3 cfs. It showed a loss of 0.41 cfs over a length of 1,470 ft in a reach where there is much vegetation.

All these seepage loss measurements were done by current metering by using a Pygmy meter and applying the velocity–area method. An electromagnetic current meter was initially used in some of the measurements, but the Pygmy meter was found to provide much more consistent and accurate results. The GPS coordinates were transformed to UTM values and plotted in a GIS over a background mosaic of aerial photographs of Cache Valley, highlighting all the flow measurement structures and also labeling all the different canal companies. Figure 1 is a simplified version of the final GIS product. The process of hyper-linking selected photographs to this GIS map was in progress at the time this paper was being prepared.

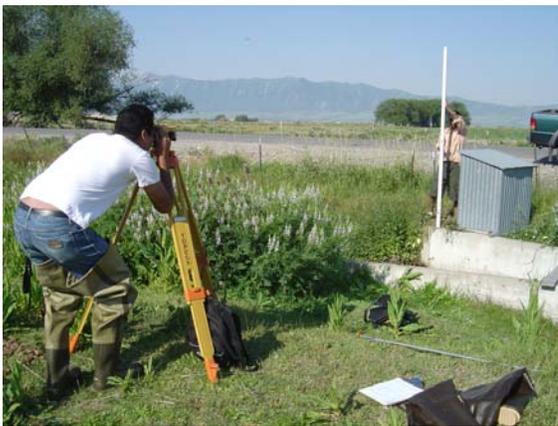
The existing measurement structures were calibrated using a current meter to measure the flow rate, taking several measurements, such as upstream and downstream depths at the structure, water surface elevations, and the channel cross section downstream of the structure. For Parshall flumes, the authors checked to determine whether it has standard dimensions. Finally, all the data were processed and the results of the current metering was compared to the standard calibration of the measurement structures.

There are some non-functional flow measurement structures found in the canals. For instance, the Logan Smithfield-Hyde Park canal has three Parshall flumes and two broad-crested weirs. One out of the three Parshall flumes was observed to be operating under submerged-flow conditions, but the measurement arrangements at the structure were made only for free-flow conditions, thereby causing large measurement errors. Two of the broad-crested weirs appear to be newly built, but they are completely submerged, so their free-flow calibrations are not applicable and the structures serve no apparent purpose.

**Fig 10.** Taking measurements to check the calibration of a flume

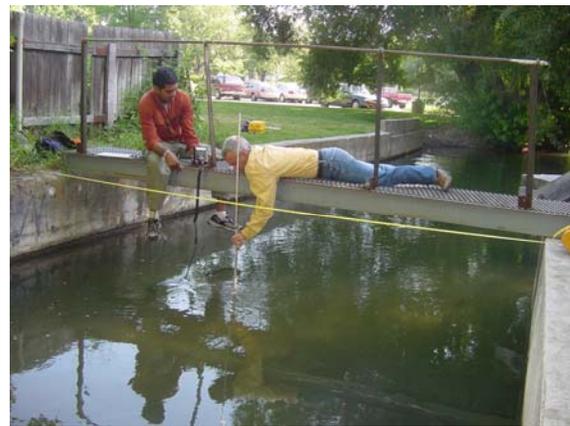
**Fig 11.** Current metering to check the calibration of a broad-crested weir

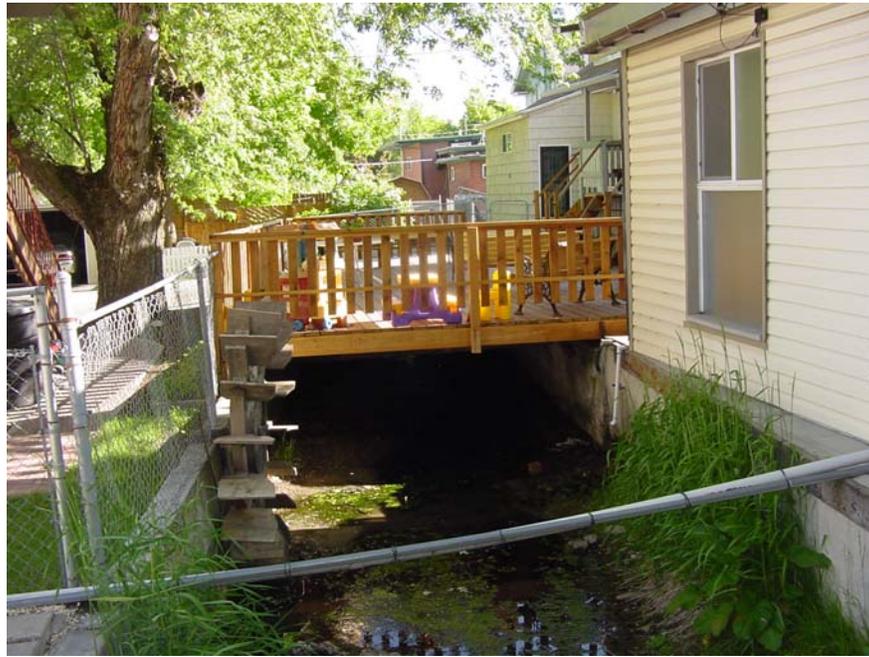
During the *Diagnostic Walk-thru* surveys, it was found that at many places along these canals there is no further access because some residential buildings have been built on the canal. This is also a problem for the canal company field staff to walk along the canal to perform operation and maintenance activities (Fig. 12).

**Fig. 12.** Obstructions along a reach of the Logan Northfield Canal
