# Treatment of SDI Emitters Clogged with Manganese Compounds

**Abstract.** *Dissolved manganese in irrigation water has contributed to emitter clogging of subsurface drip irrigation (SDI) systems in the Texas High Plains. During the 2002 growing season, areas of clogged emitters occurred in a 16-acre research field at the Texas AgriLife Research and Extension Center at Halfway, Texas. Water samples from the irrigation source were analyzed and SDI emitters in the affected areas were uncovered and examined in a laboratory setting. Evaluations indicated clogging was caused primarily by manganese oxides deposited inside SDI laterals and emitters. Observations of reactions of manganese compounds with combinations of acids and hydrogen peroxide ( $H_2O_2$ ) resulted in a protocol that dissolved these oxides in open laboratory containers. Further tests examined pressurized sections of excavated, clogged SDI laterals with  $H_2O_2$  / acid solutions for periods of up to 96 hours. This exercise led to the successful field treatment that cleared clogged emitters at the research site. Continued maintenance of the research system involved the injection of 2.5 ppm  $H_2O_2$  in slightly acidic

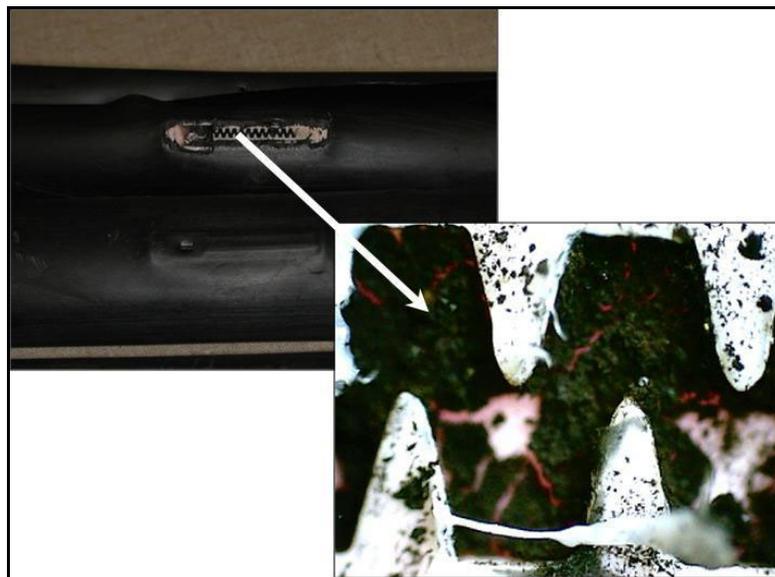
In the summer of 2002, SDI emitter clogging caused severe drought stress to cotton plants in areas within a 16-acre research field at the Texas AgriLife Research Center, Helms Research Farm at Halfway, Texas. Irrigation zone flow rates were near the design rates in September 2001 and during initial pre-plant irrigation in 2002, however they soon declined. Further investigation and analysis of residue and water samples by the Soil, Water, and Forage Testing Laboratory (Texas A&M University, College Station, TX) led to the conclusion that the primary constituents causing emitter clogging were manganese oxides. Figure 1 shows drip laterals and clogged emitters removed from the problem SDI field.

Figure 1. Clogged SDI emitters removed from research test plots at the Texas AgriLife Research Center, Halfway, 2002.

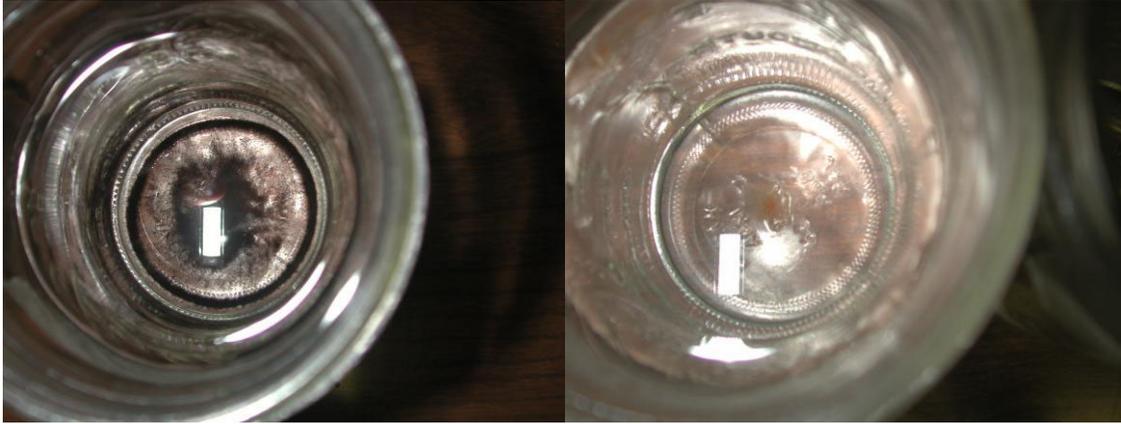
The results were promising. Figure 2 shows two jars containing 0.02 g of the Mn compound in 16 oz. of irrigation water with  $\text{H}_2\text{O}_2$  at 0.125%. The pH of the container on the left was 7.6 while that of the container on the right was 6.5. Only residual sand particles were visible in the right container as the Mn had been dissolved. The time required to dissolve the material at room temperature was within seconds.

Figure 2. Jars containing Mn at 0.15 g material/gal of irrigation water, both at 0.125% H<sub>2</sub>O<sub>2</sub> concentration. The pH of the container on the left was 7.6; the pH of the container on the right was 6.5.

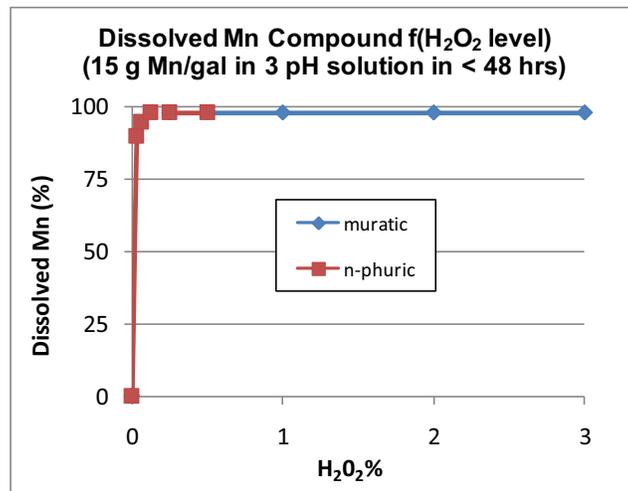
The quantity of Mn material dissolved in different solutions having H<sub>2</sub>O<sub>2</sub> concentrations ranging from 0 to 3% using muriatic acid or N-pHuric™ to lower pH is shown in Figure 3. At pH 3, 90% of the Mn compound was dissolved at 0.0312% H<sub>2</sub>O<sub>2</sub> in six hours. The acid source did not change the outcome. Due to its relative safety, N-pHuric™ (Agrium, Calgary, Canada) which contains 49% equivalent sulfuric acid and 15% of water soluble organic nitrogen was used for the remaining evaluations.

Figure 3. Percent of Mn material dissolved in solutions having H<sub>2</sub>O<sub>2</sub> concentrations of 0 to 3% using muriatic acid or N-pHuric to lower solution pH.

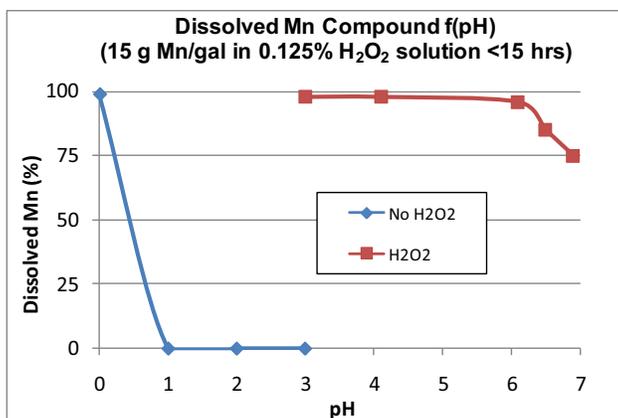
Figure 4 displays the relative quantity of Mn material dissolved in solutions having acidity ranging from 0 to 7 pH, with and without H<sub>2</sub>O<sub>2</sub>. This, as well as previous figures, show relatively small levels of H<sub>2</sub>O<sub>2</sub> dissolved the troublesome compound, but only if the pH of the solution was below 7. Acid alone was not a reasonable means for opening clogged emitters with this type Mn material.

Figure 4. Percent of Mn material dissolved in solutions having pH ranging from 0 to 7, both with and without H<sub>2</sub>O<sub>2</sub> in the solution.

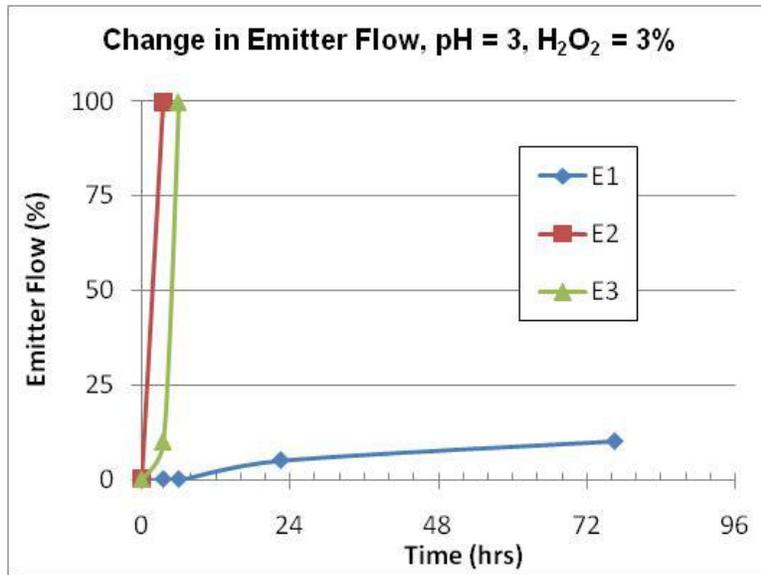
Under identical but separate treatments, two of three emitters returned to 100% design flow after 3.5 and 6 hours, respectively, when treated with 3% H<sub>2</sub>O<sub>2</sub> solution at pH 3 and pressured to 30 psi (Figure 5). Sand particles as well as additional Mn compounds were found in the third emitter after dissection following the test. Pressure effect on unclogging emitters is shown in Figure 6. Clogged emitters were treated with a 0.5% H<sub>2</sub>O<sub>2</sub> solution at pH 3 and pressurized to 12 then 30 psi versus continuous 30 psi. Immediately elevating the lateral pressure to 30 psi (emitter P3) versus starting with 12 psi then changing to 30 psi (emitters P1 and P2) resulted in full emitter flow in 4.75 hours instead of 23.5 and 33 hours, respectively. Although SDI installations are typically designed for 20 psi or less, pressure greater than standard operating pressures had major impact on the time required to open clogged emitters. The time required to open emitters was also affected by the pH and H<sub>2</sub>O<sub>2</sub> level of water forced through the emitters (Figure 7). Relative time for emitters to clear were 3.5, 20, and 78 hours from solution treatments with 0.25% H<sub>2</sub>O<sub>2</sub> at pH 3, 0.25% H<sub>2</sub>O<sub>2</sub> at pH 4.7, and 0.5% H<sub>2</sub>O<sub>2</sub> at pH 4.7, respectively with pressure at 30 psi. For these three emitters, elevated pH and reduced H<sub>2</sub>O<sub>2</sub> levels increased time for full flow. In all evaluations, once initial flow started, emitters typically cleared within a few hours.

Figure 5. Relative emitter flow over time of three random clogged emitters treated with 3% H<sub>2</sub>O<sub>2</sub> solution at pH 3 and pressurized at 30 psi.

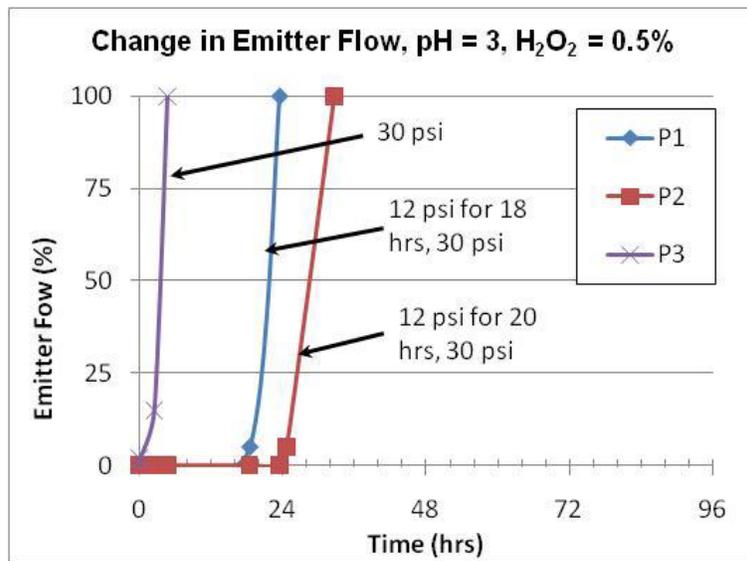
Figure 6. Relative emitter flow over time of three clogged emitters treated with a 0.5% H<sub>2</sub>O<sub>2</sub> solution at pH 3 and pressurized to 12 then 30 psi versus continuous 30 psi.

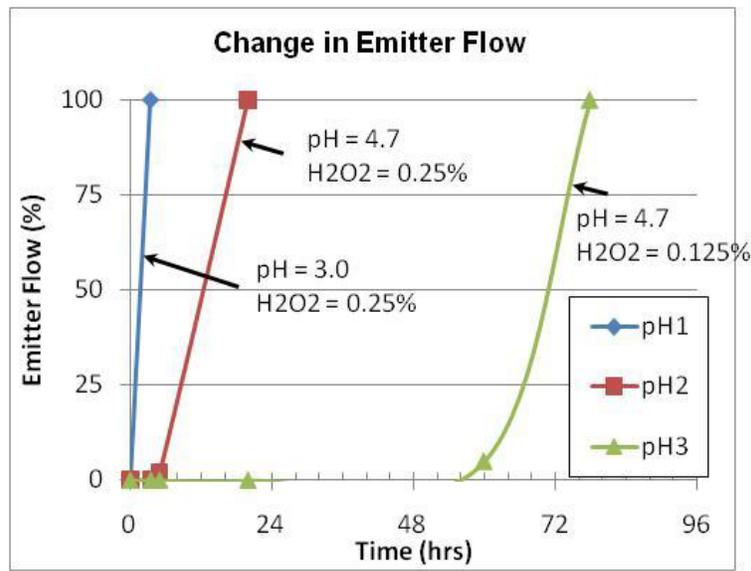
Figure 7. Relative emitter flow over time of clogged emitters treated with 0.25% H<sub>2</sub>O<sub>2</sub> at pH 3, 0.25% H<sub>2</sub>O<sub>2</sub> at pH 4.7, and 0.5% H<sub>2</sub>O<sub>2</sub> at pH 4.7 solutions with pressure at 30 psi.

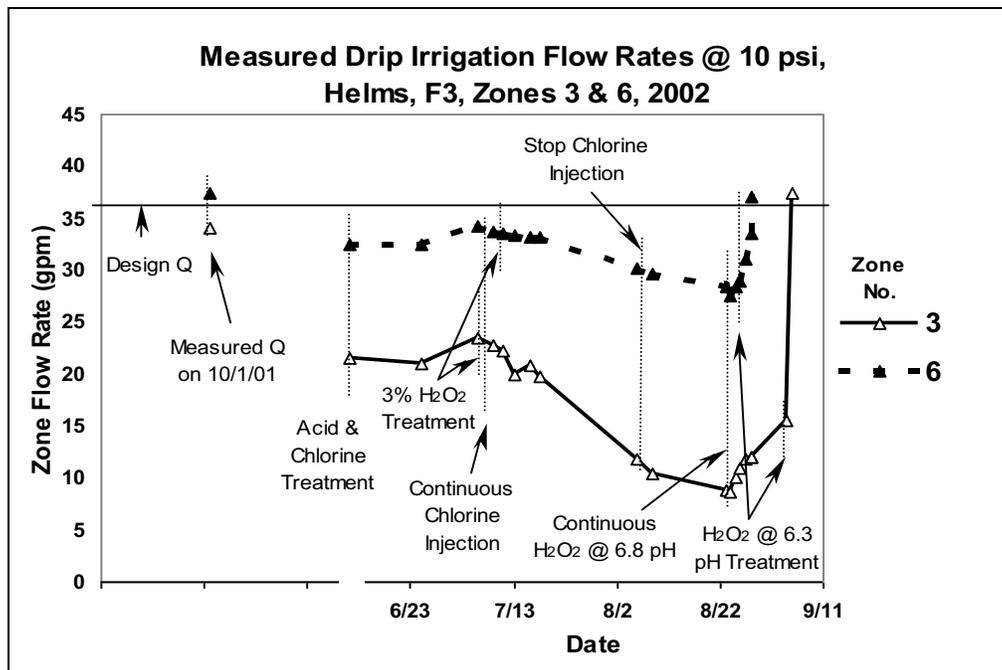
Figure 8. Flow rates and treatment events of a severely clogged zone (Zone 3) and a less severely clogged zone (Zone 6) from May until full emitter flow was reestablished in September, 2002.

Cost of materials to clean emitters on a field scale was a major concern, therefore the initial H<sub>2</sub>O<sub>2</sub> / acid field treatment used very low levels of H<sub>2</sub>O<sub>2</sub> in 6.8 pH irrigation water. Hydrogen peroxide was injected at the well at 2.5 ppm downstream from acid introduction. This process continued for 7 days in the normal irrigation cycle with notable increases in flow of all zones. However numerous emitters in the highly clogged zones did not recover. Based on the lab experiments, a field emitter reclamation process was outlined and executed.

- 7) Injection rates were readjusted to maintain pH and H<sub>2</sub>O<sub>2</sub> concentrations as zone pressures were increased to 20 psi. As emitters began to open, zone flow increased and chemical concentrations adjusted to maintain desired levels. This process continued for 6 hours in Zone 3, the zone most severely clogged. Terminating this part of the process was based on evidence of emitter flow from previously clogged emitters. Hydrogen peroxide bubbles “erupted” on the soil surface above covered emitters that were not fully clogged.

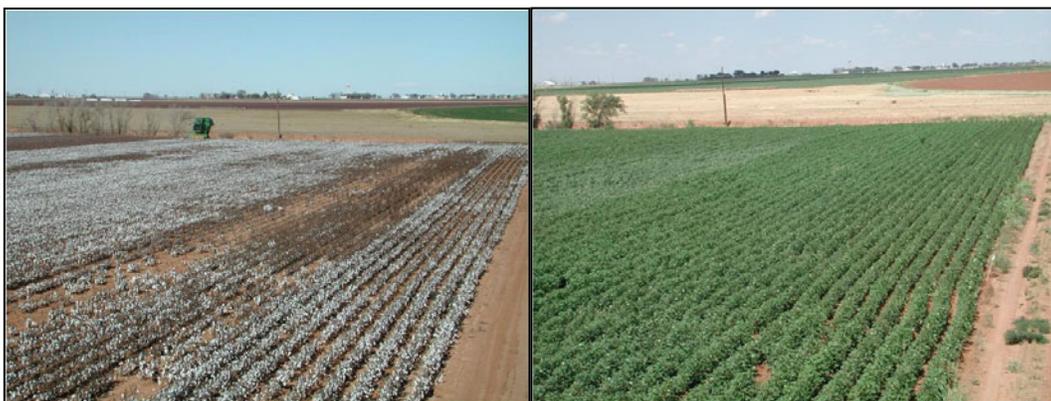
Figure 9 shows the effects of emitter clogging on cotton growth in 2002 and the result of the reclamation process at the same locations in 2003.

Figure 9. Effects of SDI emitter clogging on cotton production in 2002 (left) and cotton in 2003 at the same location following SDI system reclamation (right).

- 9) After all zones were treated, the normal operation cycle for irrigation was resumed. In all zones, flow rates recovered to the original design level.

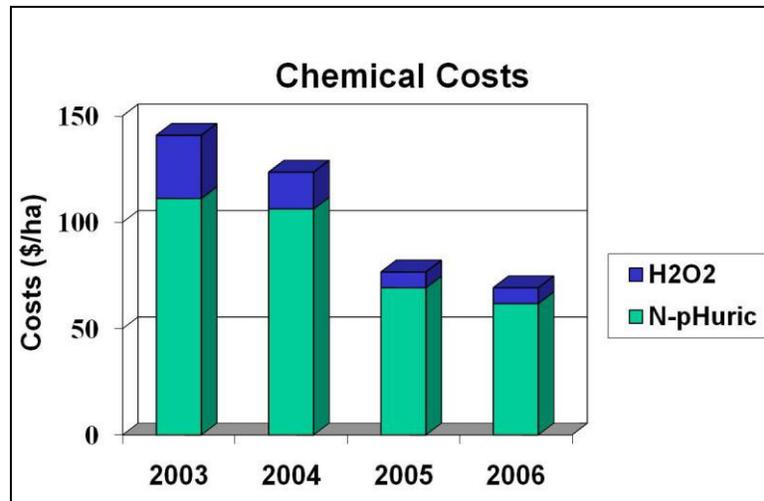
The cost of maintenance treatments from 2003 to 2006 is given in Figure 10.

Figure 10. Hydrogen peroxide and acid costs for maintenance of SDI systems at the Texas AgriLife Research Center, Helms Research Farm, 2003-2006.

The maintenance procedure was changed in 2005 in an attempt to reduce the cost of materials. Injections of chemical were modified from continuous injection to injection every other 2-week period. At the end of periods without injection, brown and black deposits were seen on the site glasses at filter stations. At this point, zone flows were not yet affected. Re-establishing H<sub>2</sub>O<sub>2</sub> / acid injections at the maintenance rates reduced these deposits within 2 weeks. There has been no evidence of emitter clogging since 2002.

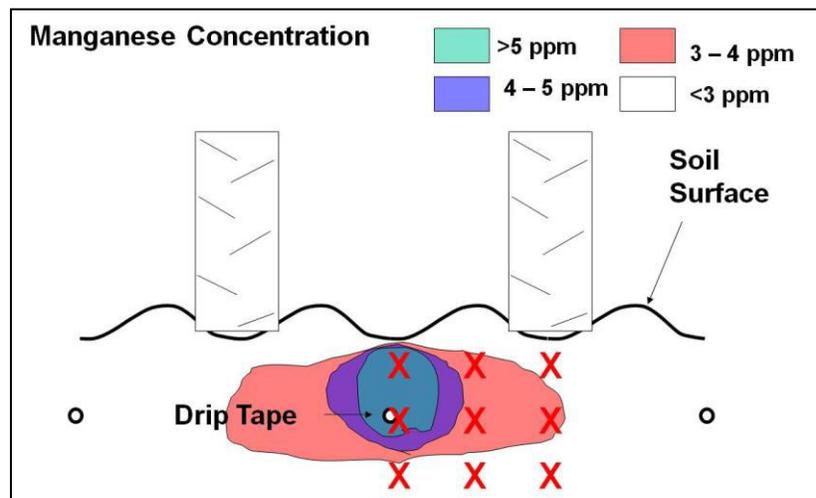
Manganese found in these soil samples ranged from <1 ppm to slightly greater than 5 ppm. Figure 11 shows soil sample locations and average residual Mn concentrations around drip laterals in treatments irrigated at approximately 80% crop evapotranspiration. Although Mn concentrations have appeared to follow SDI wetting patterns, the quantities of this element are well below toxic levels for cotton plants. Mn concentrations in the root zone have continued to be monitored with no significant increases since 2003.

Figure 11. Soil sample locations and average residual manganese concentrations around SDI laterals, Helms Farm, Halfway, TX, 2003.
