# Update on Variable Rate Irrigation Performance

Jacob L LaRue, P.E.

Valmont Irrigation, Valley, Nebraska USA [jlalrue@valmont.com](mailto:jlalrue@valmont.com)

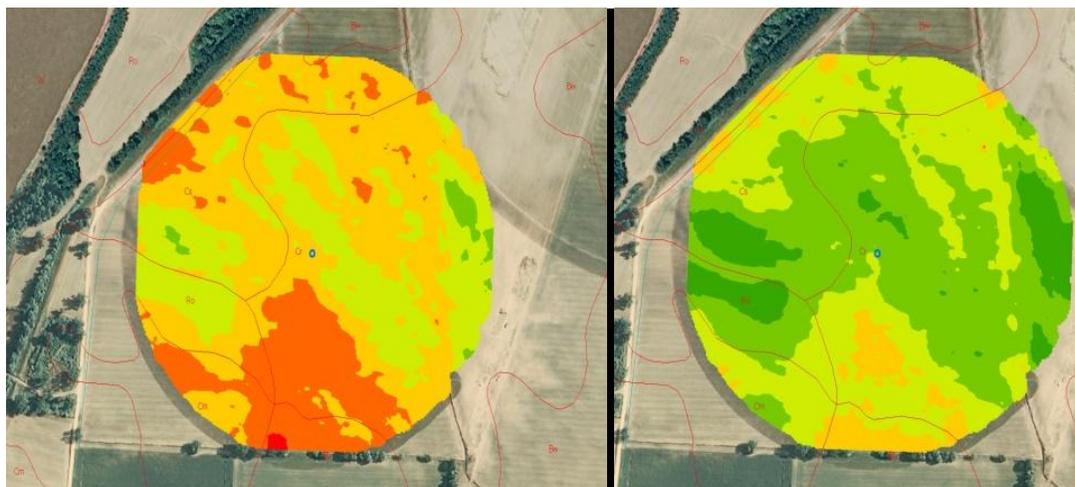
Figure 2

In the spring of 2010, Valmont Irrigation began to validate the lab and field testing that had been done with the Valley VRI Zone Control package on a field near Dyersburg, Tennessee. The machine's configuration was a total length of 350m (1,148 ft) and six drive units. The flow rate was 51lps (800gpm) with fixed-pad sprinklers with a medium groove pad and regulator. The field challenge was parts of the field were either being overwatered or under watered, and uniform crop production was not being achieved across the field. In conversations with Dr. Earl Vories of USDA-ARS about VRI and how to determine the layout of Management Zones, it was suggested by Dr. Vories that apparent electrical conductivity ( $EC_a$ ) of the soil profile be used (Vories 2008).  $EC_a$  is a sensor-based measurement that provides an indirect indicator of important soil physical and chemical properties.

Deep  $EC_a$

Shallow  $EC_a$

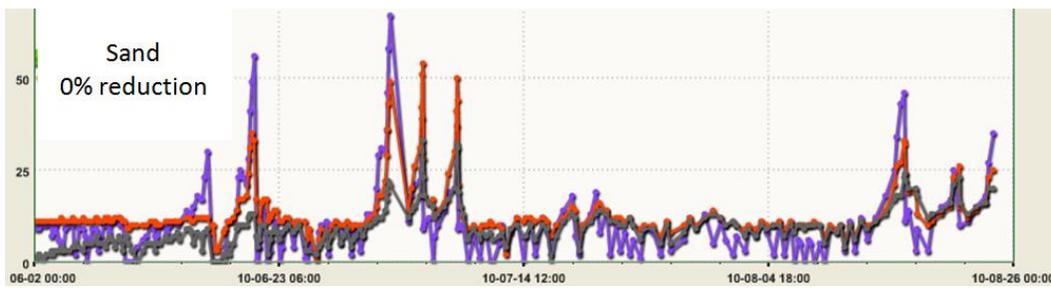
The soil moisture data was tracked remotely; it looked for drying trends in the area where the prescription called for a reduced application depth. Below is an example of the soil moisture data sets for a sample time period (Figure 4a and 4b).

Figure 4a is an area with clay loam soil that received 60% (40% reduction) of the base application depth. Figure 4b is an area of fine sand that always received 100% of the base depth. Each area received the same number of irrigations. Most important from this data is that over time, the clay loam with the reduced application depth did not show a drying trend; for most of the crop season it paralleled the soil moisture status of the area that received 100% of the base application depth.

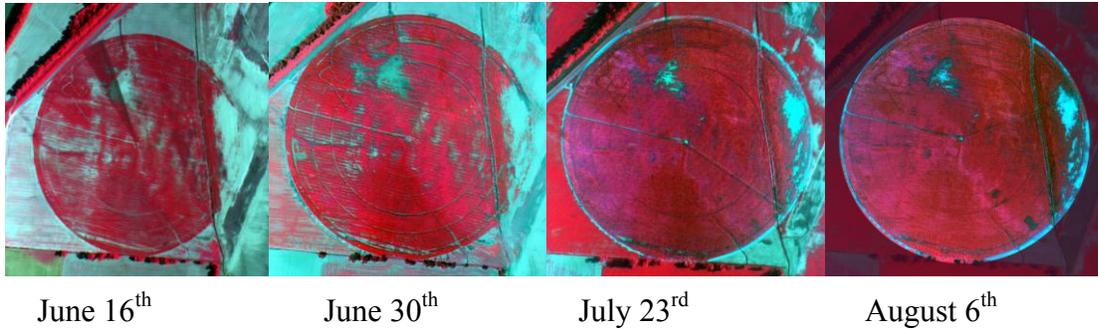
Figure 5

The following were a series of infrared images taken during the growing season

In the images above, there was gradual improvement in the ground cover and, in general, the crop appeared “good” across the field with no particular weak areas except for the areas where the crop was blown out by wind in the early season.

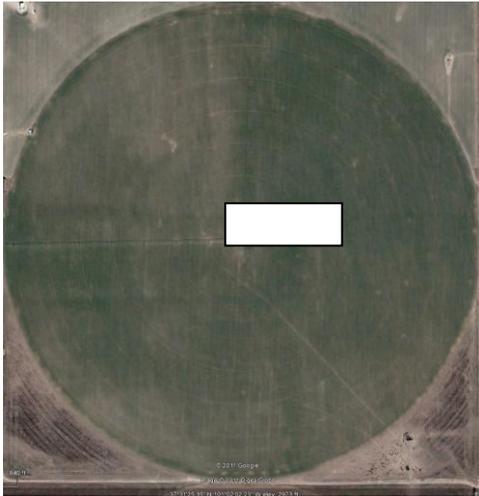
Figure 6 is an aerial shot of the center pivot and figure 7 presents the soil moisture grid data. All sensors were positioned 15 cm (6in) deep in a grid pattern. The 100% shows irrigations and the soil profile being refilled. The 30% gradually shows a drying and after irrigation and the soil profile not being refilled. No other data was collected from this center pivot

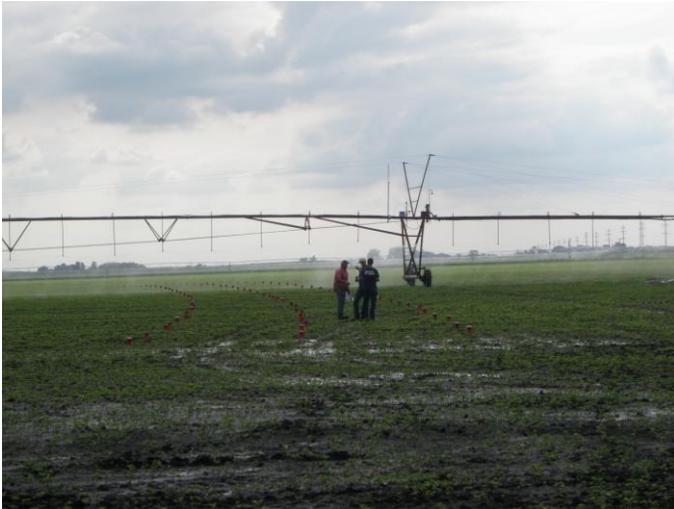
Figure 10 shows a catch can layout during a test. The cans are in three lines in an arc under a specific zone. The center pivot is operated ahead of the catch can arc to ensure everything is operating okay and then started into the catch can area. After the center pivot moves across 1/3 to 1/2 of the catch cans then the prescription is changed and then later changed back.

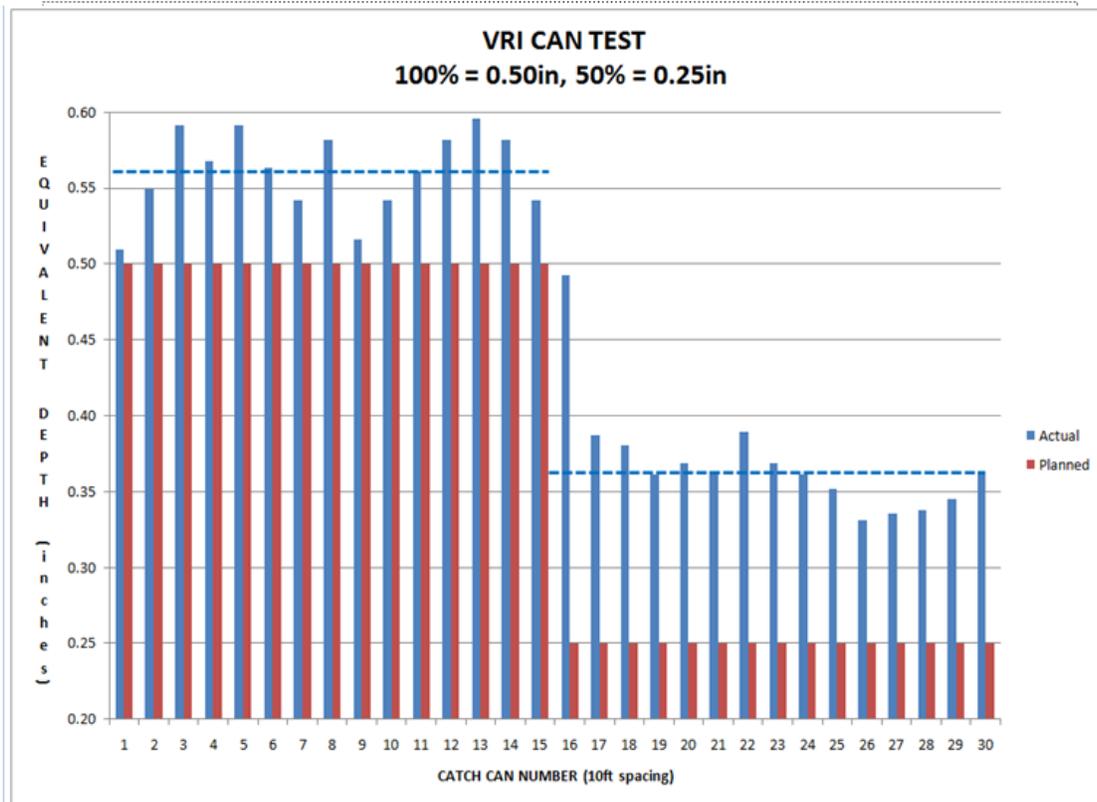
Figure 12 represents one of the passes and the data of the catch can test. The red bars represent the application depth that was planned to be applied and the blue bars the actual average of the three catch cans that are side by side. This center pivot had a rotating sprinkler package mounted on drops about 2.5m (8ft) off of the ground.

In figure 12 there are a couple of points to note:

- The transition between prescriptions appears to occur in about 6m (20ft)
- Both at 100% and 50% prescriptions applied a depth greater than expected
  - At the 100% it was determined there was an error in the panel constants which explains the difference
  - At the 50% setting even with the panel constant adjustment the difference is not totally understood. As soon as the crop is harvested additional tests will be run with more catch can tests to characterize the performance.
- The Christiansen coefficient shown in figure 13 shows good uniformity but a definite difference with higher values at 100% prescription and lower values when the nozzles are being pulsed on and off to achieve the 50% prescription which seems to make sense.

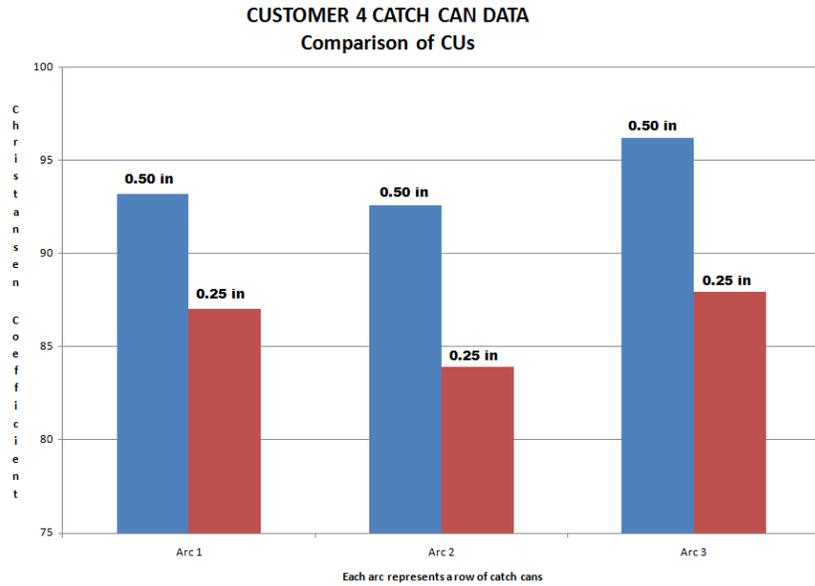
Figure 13 shows the Christiansen Coefficient for each segment of the arc. The blue bars are each arc for the area of 12mm (0.50in) application depth. The red bars represent the lines when applying 6mm (0.25in).

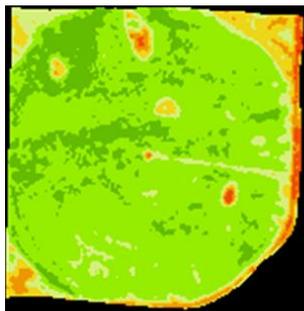
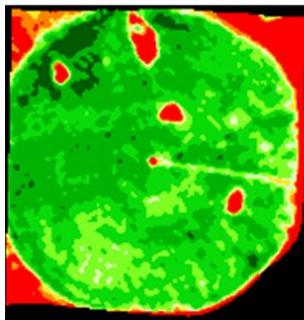
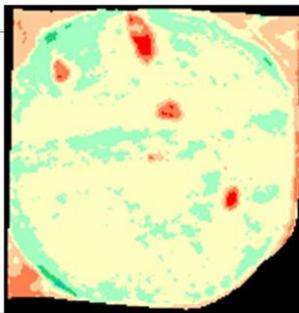
NDVI

Figure 14 shows three examples of aerial imagery that was collected on July 12<sup>th</sup>.

Again due to the rainfall no trends were observed during the growing season when comparing one image to the next taken three to four weeks later.

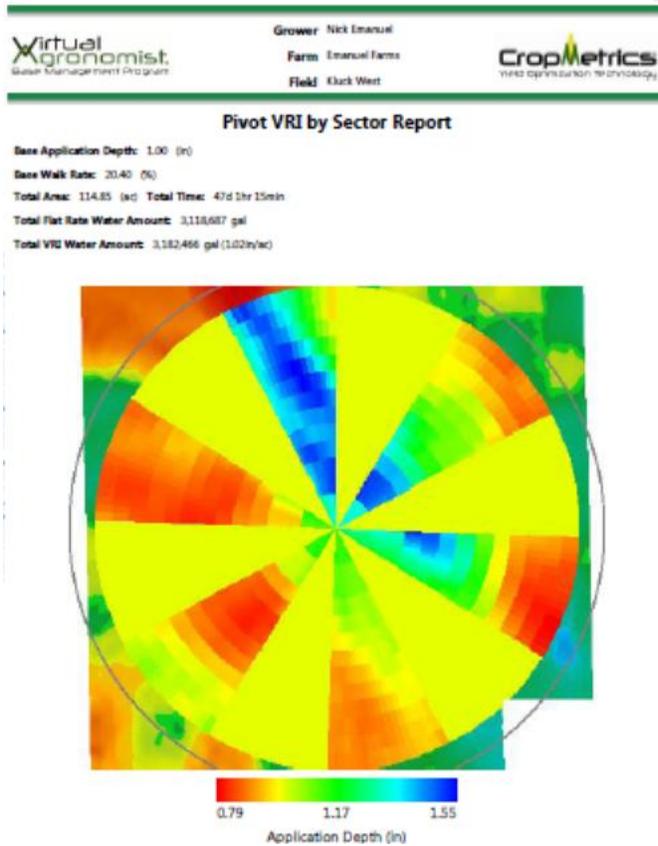
Figure 15 represents the prescription used for the center pivot in eastern Nebraska. The owner working with CropMetrics wanted to do some testing of prescriptions vs. no prescriptions.

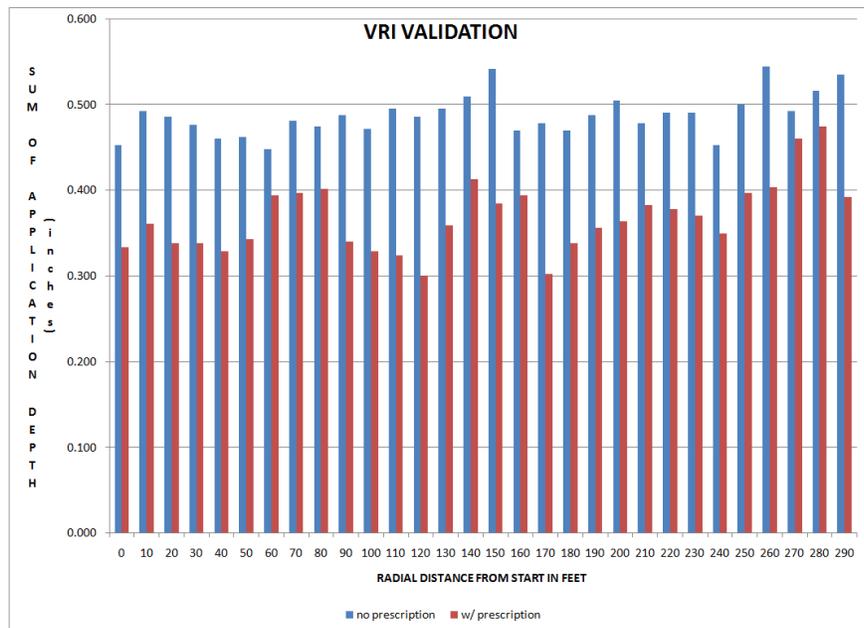
Figure 16

Catch can data is shown in figure 16. The blue bars represent the average of the three catch cans operating with no prescription and the red bars with a prescription of 100% - 50%. The sprinkler package used rotating pads on top of the pipeline.

In figure 16 there is primary point to note:

- Due to the wide patterns of the rotating pad sprinklers on top of the pipe the transition is not visible between prescriptions and for tests to be meaningful need to run characterization with much larger zones.
- With vs. without prescription showed different application depths which is not completely understood and again needs more testing as the wind was at a higher speed than we would have liked for the without prescription and suspect the drift would account for the differences.

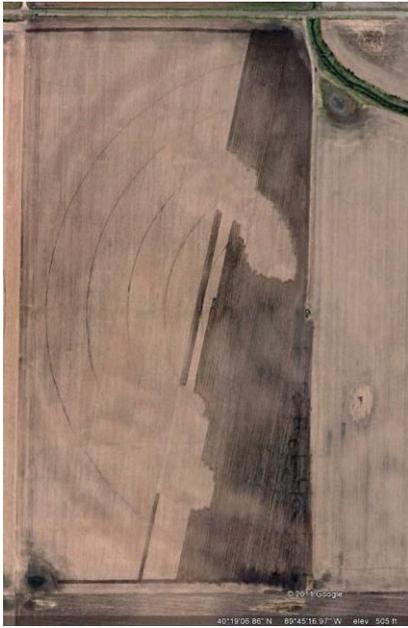
Figure 17 is an aerial image of the field used for initial planning purposes.

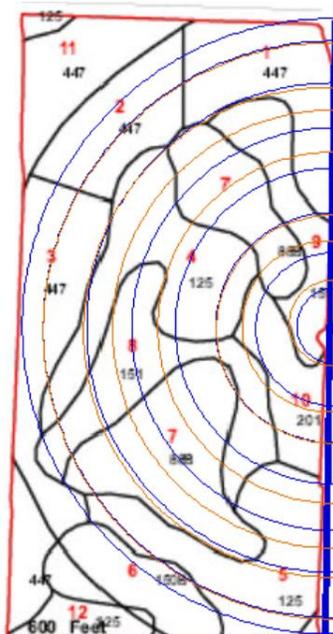
Figure 18 shows the soils map in relationship to the center pivot drive units and the VRI zones.

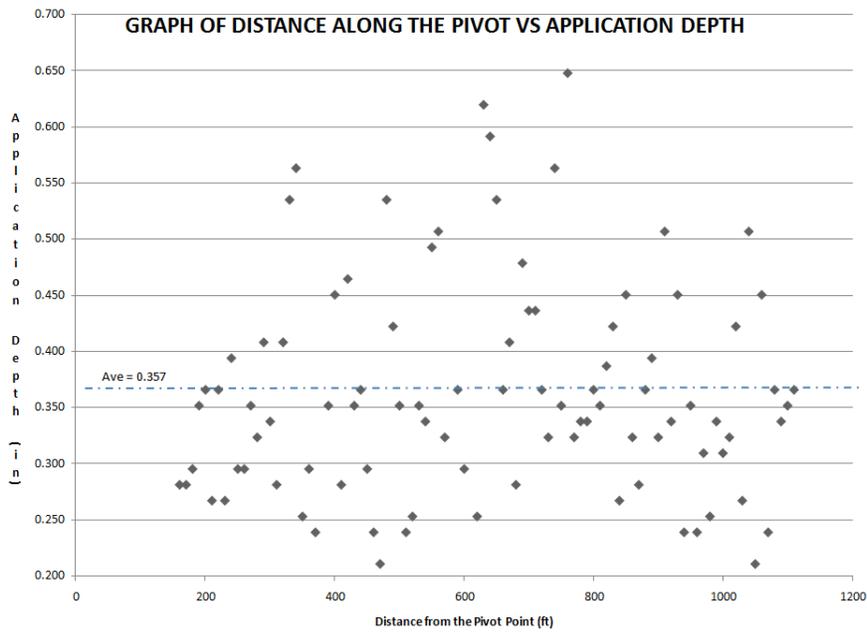
Figure 19 above illustrates a catch can test where the cans were set in a line 3m (10ft) apart parallel to the center pivot and the pivot run across the catch cans applying 12mm (0.50in) without a prescription running.

Sprinkler uniformity by catch can testing – along the center pivot. Only one good test was able to be run as shown in figure 19. This data indicated more scatter than we expected and a Heerman and Hein coefficient of 88.

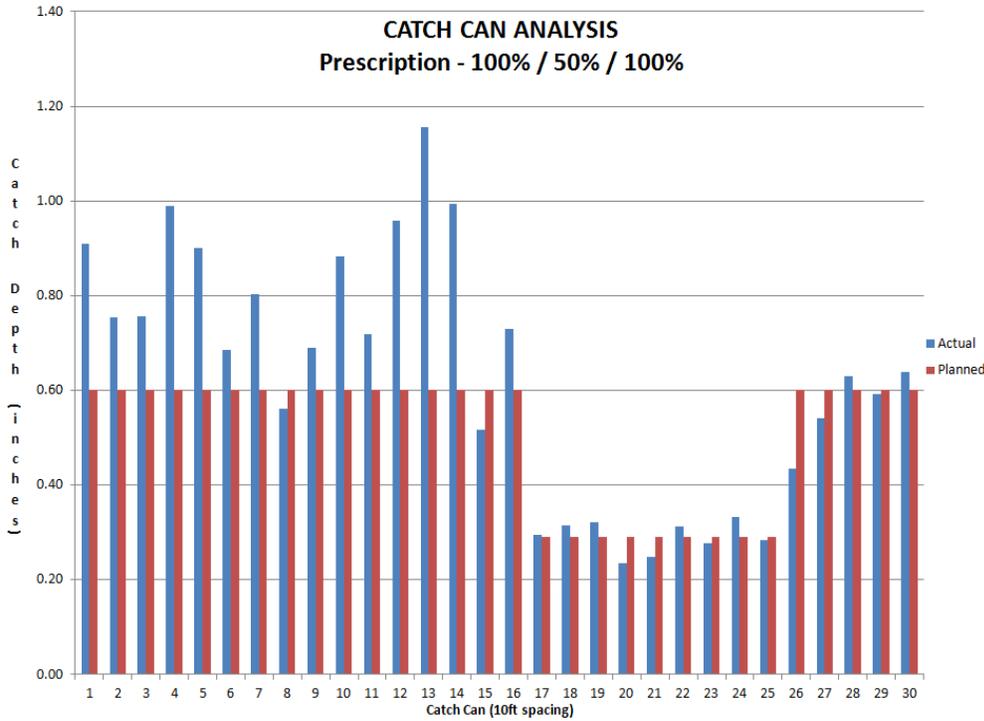
Figure 20 shows the average volume collected. The red line show planned and the blue the actual depth.

The sprinklers were fixed head sprays at 2m (6ft) ground clearance.

Started applying 15mm (0.60in) , switched to 4.5mm (0.30in) and then back to 15mm (0.60in)

In figure 20 there are a couple of points to note:

- The transition between prescriptions appears to occur in about 6m (20ft) switch from 100% to 50% but 9m (30ft) when switching back to 100%. Again this was the best run due to wind and anticipate more testing this fall.
- Both at 100% and 50% prescriptions applied a depth close to expected

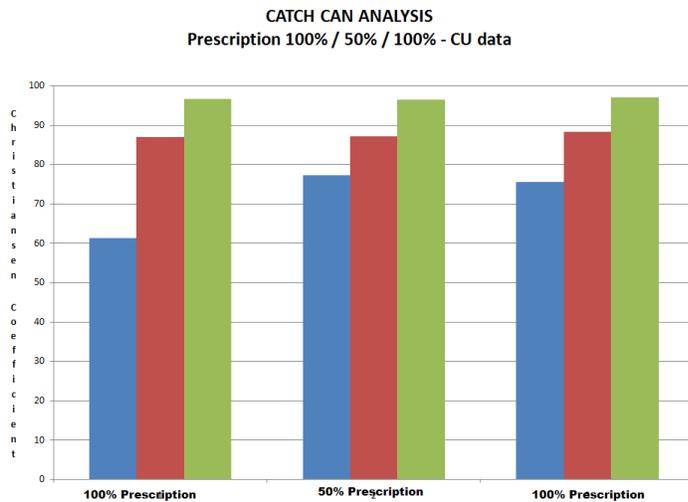
Figure 21 shows the Christiansen coefficient for each of the catch can segments at the various prescriptions

- The Christiansen coefficient shown in figure 21 indicates a difference between the lines which may be more related to the position in relation to the sprinkler head than anything. When pulsing, at 50% did not show significantly lower uniformity than at 100%.
