Evaluation of RDI™ Precision Irrigation

Jacob LaRue

Valmont® Industries, Valley, Nebraska, jlarue@valmont.com

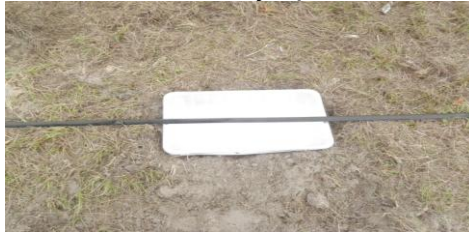
- Goal - determination of basic characteristics of the tube
- Success – defined as relatively uniform delivery based on a crude test
- Area - ~ 0.10 acres
- Plan –
 - Water source – well
 - Filter - none
 - Soil - sand
 - Lay tube on the soil surface with minimal elevation change
 - Space lines 30 inches apart x 800 feet long
 - Operating pressure – 2.1 PSI
 - This pressure was just above the point of breaking surface tension to encourage flow
 - Pressure controlled with a head tank
- Crop - none
- Measurements
 - Pressure at the beginning and end of tubes
 - Measured with a manometer tube
 - Flow at 100 foot locations along the tube

- Measured with trays placed under the tube

Figure 1. Test setup

- Success – best as could measure met expectations
- Comment – Interesting phenomenon noted was touching the tube would increase the flow. Believe the oils on the fingers were breaking the surface tension and potentially disrupting flow. Made accurate measurements very difficult.

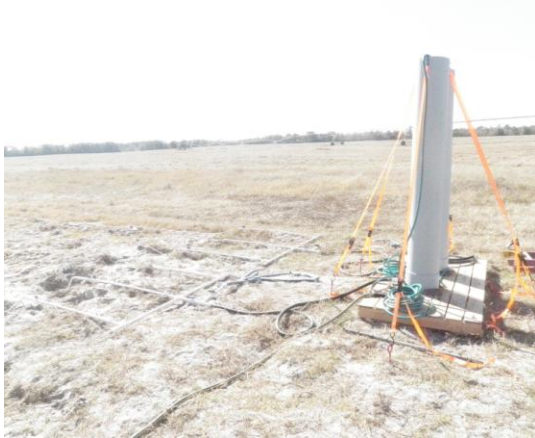
- Pressure controlled with a head tank
 - Plant groups of plants at locations along the tubes
 - One group of ornamentals planted near irrigated plants as a control

Figure 2. Control system

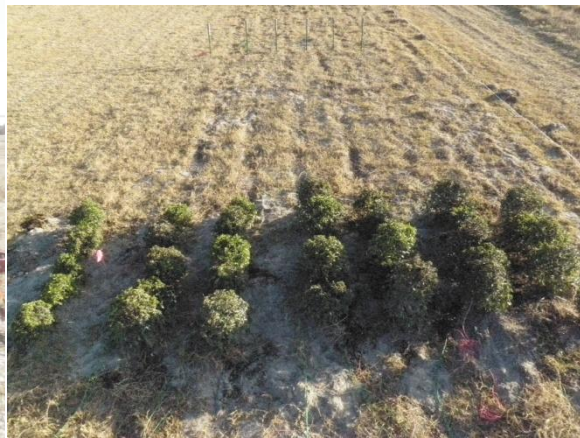
- If the plant roots were within the wetted area provided by the tube, then growth occurred; but, if the roots did not reach the wetted area, no growth occurred.

Figure 3. Example of plants

- Success –
 - Partial success in Phase IIa due to installation not meeting expectations
 - Plants in areas where the lines were collapsed did not grow
 - Fully in Phase IIb when lines reinstalled – 70% of plants grew

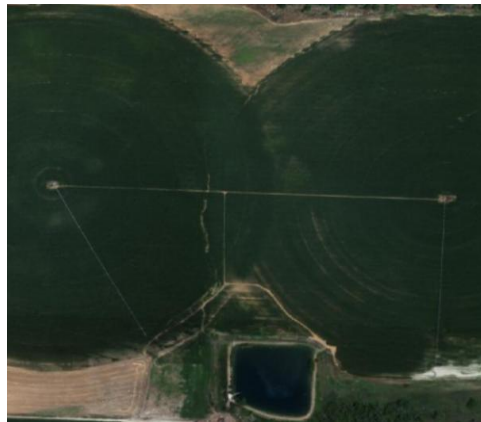
Figure 4. Aerial of field area

- Goal - determination how the tube would perform in a semi-commercial setting with corn in the corner of center pivots
- Success – defined as crop yields of 80% of center pivot
- Area - ~ 1.5 acres

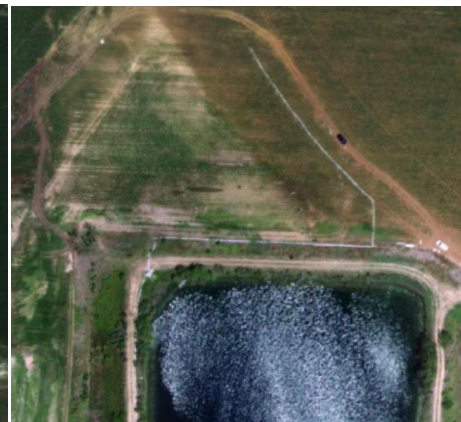
Figure 5. Plot area

- Plan –
 - Water source – pond
 - None – first challenge to see if the tubes would plug
 - Soil – loamy sand
 - Bury tube ten inches deep
 - Multiple replicated trials including non irrigated
 - Lines spaced at 30 inches apart with lengths of 150 feet to 750 feet
 - Operating pressure – 2.1 PSI
 - Pressure controlled with a head tank
- Crop –

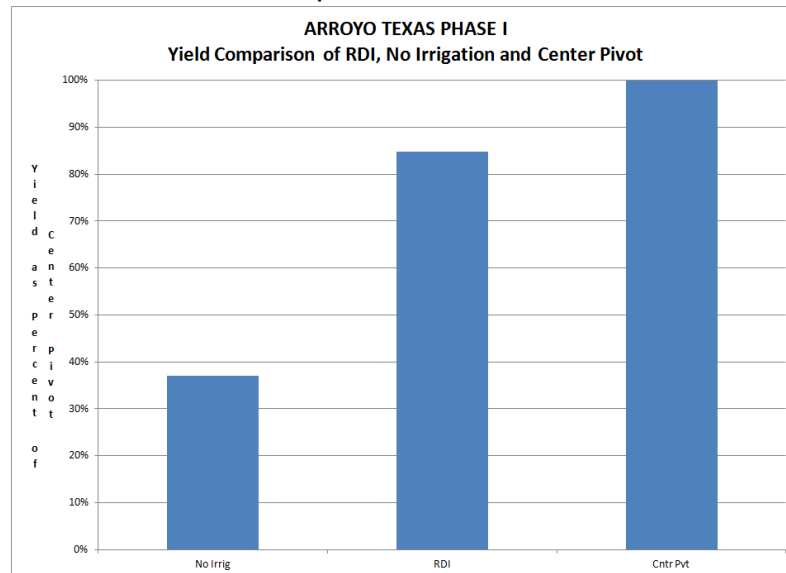
- #2 yellow corn planted at about 32,000 plants per acre
- Tillage same as under the center pivots
- Planted at the same time as the center pivots with the rows straight through
- Slope of three feet maximum across the plot
- Measurements
 - Pressure at the beginning and end of tubes
 - Flow with Netafim™ Fertilizer flowmeters
 - Soil moisture with Irrrometer WATERMARKs
 - Yield by hand harvest of areas near Irrrometer stations
- Success –
 - Yield of 85% of center pivot

Table 1. Yield information

- Comment –
 - Soil moisture at time of planting was near field capacity to depth of two feet
 - Some weed issues in plots as corner area had not been farmed for several years
 - Far ends of lines run over by farmer limited maximum useable length to 500 feet
 - Did not observe any change in flow along the tube, even though significant moss and algae were growing in the pond

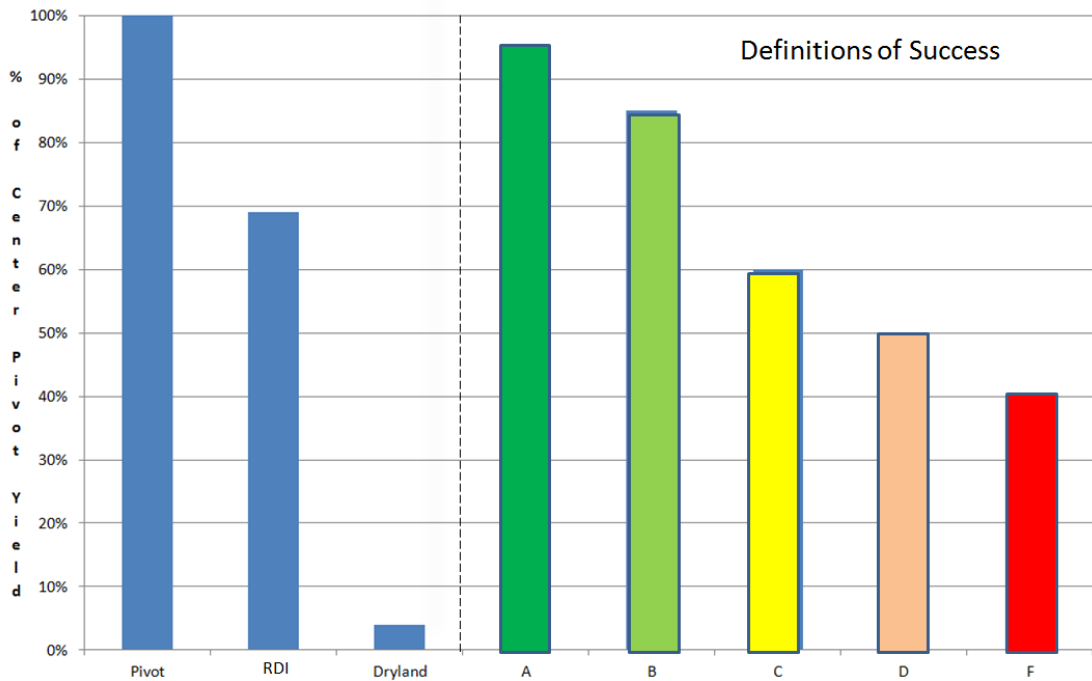
- Moved to a new area in a different corner of the center pivot
- Water source – pond
- Filter - none
- Soil – loamy sand
- Bury tube ten inches deep
- Multiple replicated trials including non irrigated
- Lines spaced at 30 inches apart with lengths of 1,200 feet
- Operating pressure – 2.1 PSI
- Pressure controlled with a pump
- Crop –
 - #2 yellow corn planted at about 32,000 plants per acre
 - Tillage same as under the center pivots
 - Planted at the same time as the center pivots
 - Slope of eight to ten feet across the field
- Measurements
 - Pressure at the beginning and end of tubes
 - Flow with Netafim Fertilizer flowmeters
 - Soil moisture with Irrrometer WATERMARKs
 - Yield by hand harvest of areas near Irrrometer stations
- Success –
 - Yield of 68% of center pivot – Grade of B-

ARROYO TEXAS PHASE II
Treatment vs % of Center Pivot including Success

Table 2. Yield vs. success

- Comment –
 - Soil moisture at time of planting was near 50% depleted – it was dry

- Stand was uneven due to germination delayed until rain about two weeks after planting
- Some weed issues due to challenges of farmer being able to spray around manometers and Irrrometer stations
- Insufficient water to operate the furrow irrigation plots

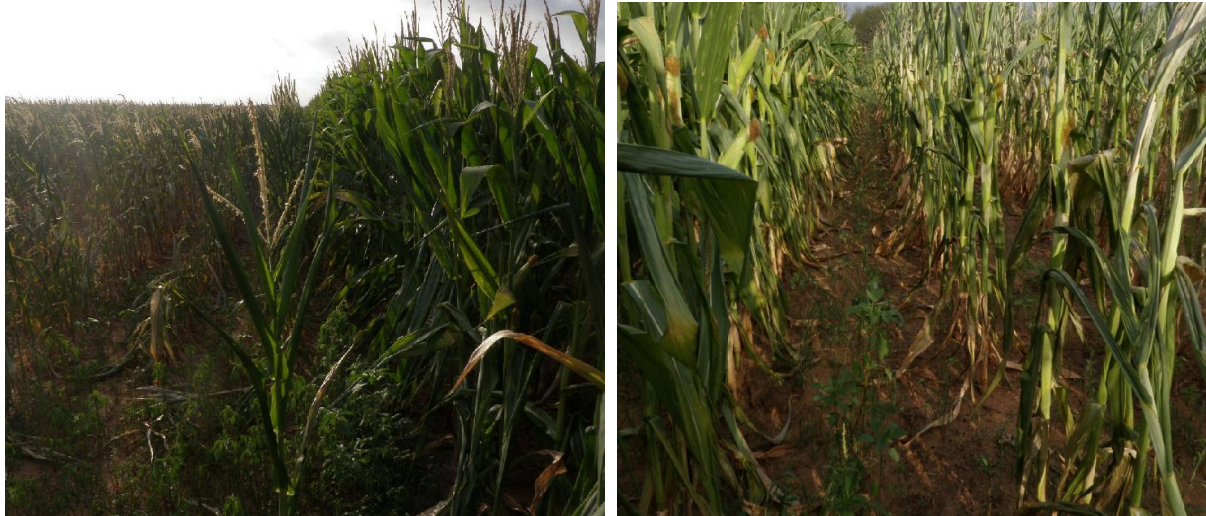
Figure 6. Examples of plot crop

- Comment –
 - Again, the soil moisture at time of planting was near 30% depleted – it was dry
 - Stand was uneven due to germination delayed until rain about two weeks after planting
 - Some weed issues due to challenges of farmer being able to spray around manometers and Irrrometer stations
 - Biggest challenge was water shortage twice during the crop cycle - once for ten days and again for six days
 - Again there was insufficient water to operate the furrow irrigated plots
