Increasing Water-Use Efficiency Using Block-Zone Design on Tees

Russell A. Geiger, CGIA, CGCS, MS Ag. Eng.

Hydrologic Irrigation Design, Consulting and Engineering

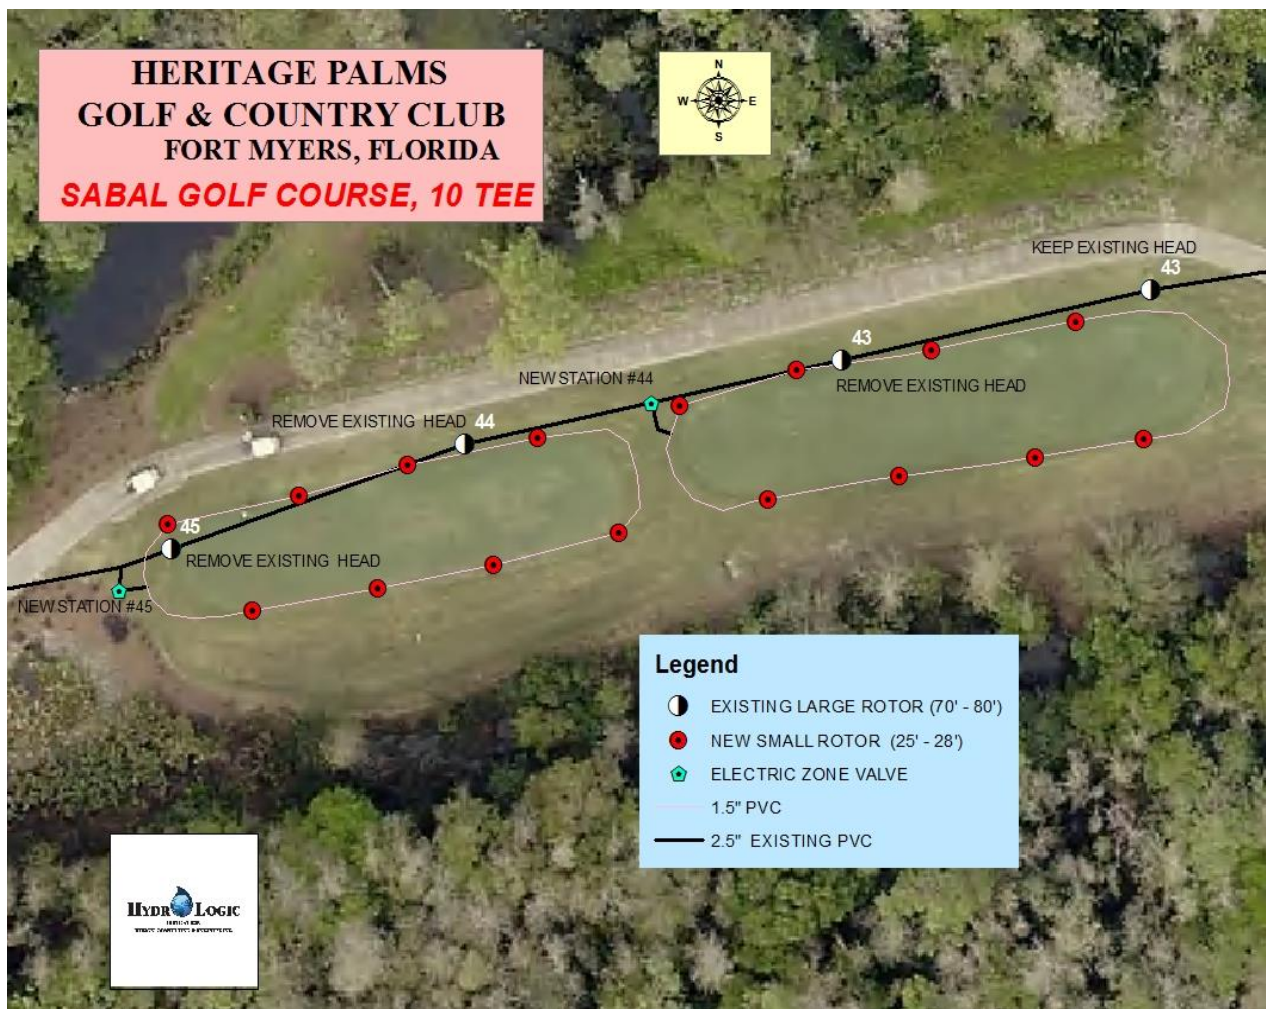
Figure 1. Aerial image of site with new design overlay

The case-study subject area is the number 10 tee complex on the Sable golf course at Heritage Palms Golf and Country Club located in Fort Myers, Florida. This particular tee complex has two separate teeing areas which are referred to as the “East” and “West” tees respectively. The corridor of turf that comprises the overall tee complex is relatively narrow and long, approximately 50 feet in width and 250 feet in length. The number 10 tee complex is very typical and representative of many other tee complexes in place on the two 18-hole golf courses at Heritage Palms.

A new “block-zone” irrigation design was created for the same tee complex. Each of the two teeing surfaces were looped with 1.5 inch PVC pipe that tapped into the existing 2.5 inch PVC lateral pipe. The looped configuration supports more consistent pressure throughout the zone and permits the location of the new smaller rotors to be on both sides of the tee complex (opposed to previous “single-row”) which significantly increases coverage and uniformity. The original larger rotors were replaced by 16 small rotors with spacing ranging from 25 to 28 feet apart. The smaller rotor sprinklers utilized a nozzle configuration that operated each head at a discharge rate of approximately 6.5 gallons per minute at a working pressure of 80 psi. Zone valves provided control for the new sprinklers and utilized the existing station wires that had previously controlled the larger original rotors with electric solenoid valve-in-head configuration.

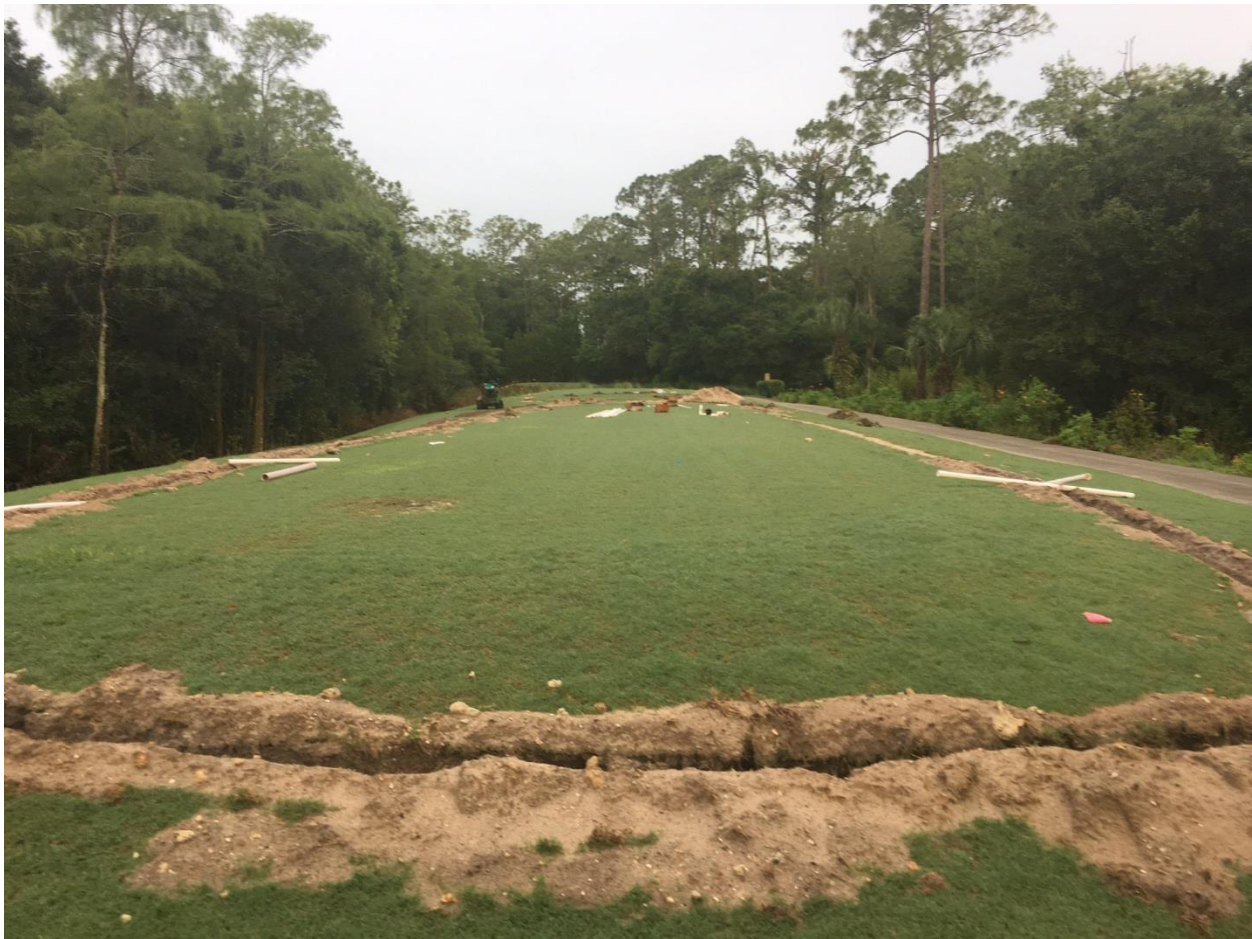
Figure2. Installation of new block-zone design, note the narrow width of the irrigated site
