Pumping Energy Efficiency - more than just testing pumps

Presentation to Irrigation Association Conference, 2018, Long Beach, California.

Robert L Welke - Australia

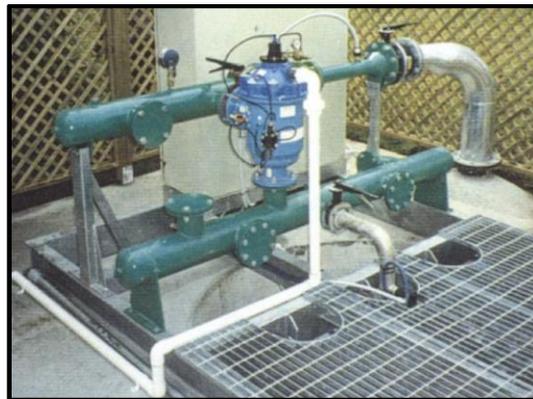
Figure 3: A recycled water irrigation pump station was installed initially with one filter, one pump. Later, the second pump was added, but not the second filter. This resulted in significant maintenance and early failure of the single filter. In addition, when the second pump was installed, the clean water head loss across the filter increased from 1m (3') to 4m (13'), a 3 metre (10 feet) head loss increase, costing approx \$5,000 over 15 yrs in pumping electricity costs.

A recycled water irrigation pumping system designed and commissioned by the author (as an employee of Hydrotech Aust) was installed in an irrigation system at Sanctuary Cove, Gold Coast, QLD, in 1997.

It was designed to operate ultimately with 2 pumps and two filters but was installed in Stage 1 with only one pump and one filter. The client later added a second pump, but did not add the second filter, to save costs.

The author, in the capacity of an independent consultant, was called to site about 10 years later, to discover that the single filter had a history of wear and malfunction. The addition of the second filter would have averted this situation.

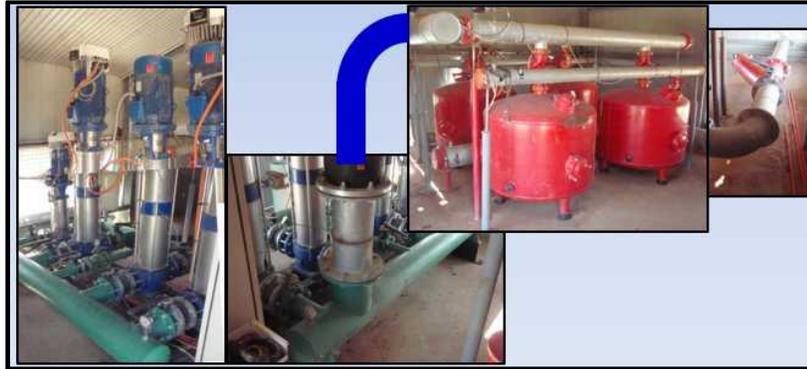
Figure 4: This collage of photos shows a three pump system teamed up with a massive 4 x 48" media filtration system, requiring a flow output 50% in addition to the pump system capacity during backflush, but which was not allowed for. With no pressure sustaining valve, the result was that the pumps and VFD's suffered periodic failure, not to mention the significant field pressure loss during backflush and hence low CU's and DU's to the golf course it served.

A three pump recycled water pumping station was designed and assembled by the author in 1999 (whilst an employee of Hydrotech Aust Pty Ltd), to specifications for a contractor acting on behalf of a golf course in central NSW. The pumping system was installed by the contractor, but no commissioning was requested.

A brief visual audit (free of charge) established that (unbeknown to the author at the time the pump system was supplied) four x 48" media filters were deployed after the pumps. The filter backflush flow rate added 50% additional flow rate over and above the pumps' maximum output. As no pressure sustaining valve was ever installed, the pumps spent much of their life running off the end of their curve and cavitating.

This is a case of simply the wrong filter selection, and no local knowledge to recognise the problem that it produced.

The energy efficiency cost of this disaster can only be imagined. It could be measured in terms of pump down time labour, pump and VFD repairs, plus a significant amount of additional pumping to overcome the extremely poor CU's and DU's which would have resulted from irrigating with virtually no field pressure for the duration of 4 x 48" media filters backflush, probably 40 minutes each backflush cycle.
