# Earthquakes and Irrigation in the Mexicali Valley

**Charles M. Burt, Ph.D., P.E., CID, CAIS**

**Abstract.** *On April 4, 2010, a 7.2 magnitude earthquake occurred within the Mexicali Valley approximately 30 miles south of the U.S. Border. Fields and canals within approximately 64,000 acres were severely damaged, with about 141,000 total acres damaged. This paper reports on the types of irrigation and drainage damage that occurred, the response by the governments and farmers, and the corrective efforts that have been and will be made on-farm and to the irrigation water distribution system that supplies the canals.*

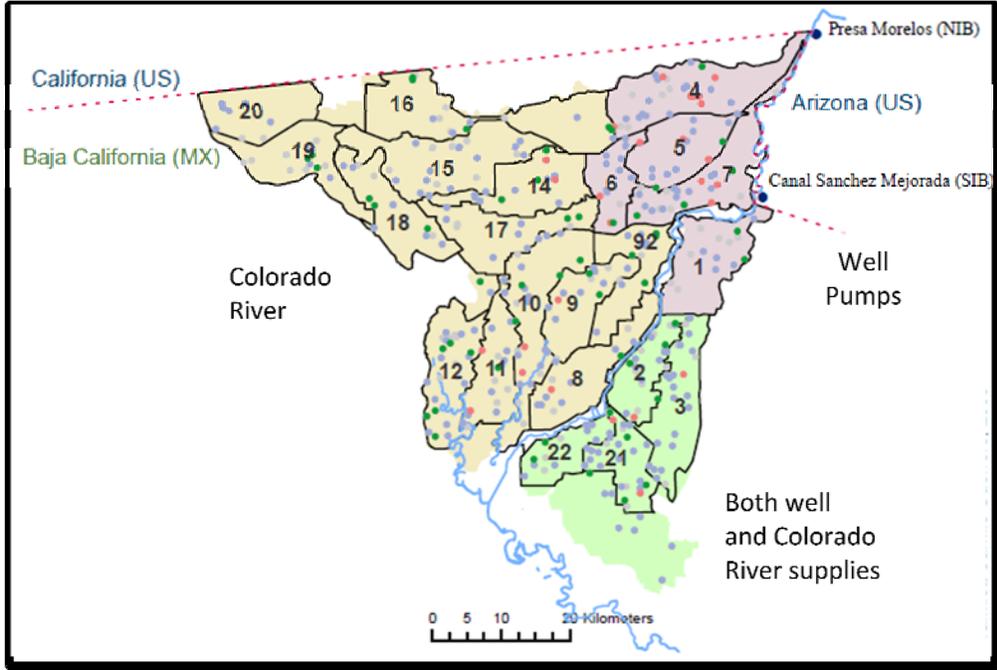
Figure 11. District 014 (Mexicali Valley) showing Modulos (by number) and sources of water (by color).

The modulos that suffered the most damage were Modulos 10, 11, and 12 (see Figure 11). The irrigation water to these modulos was supplied by the concrete-lined Nuevo Delta Canal (about 15 miles long), which was in turn supplied by the Reforma Canal, which receives its water from the Colorado River at Morelos Dam (Presa Morelos on Figure 11). The Nuevo Delta Canal was almost completely destroyed.

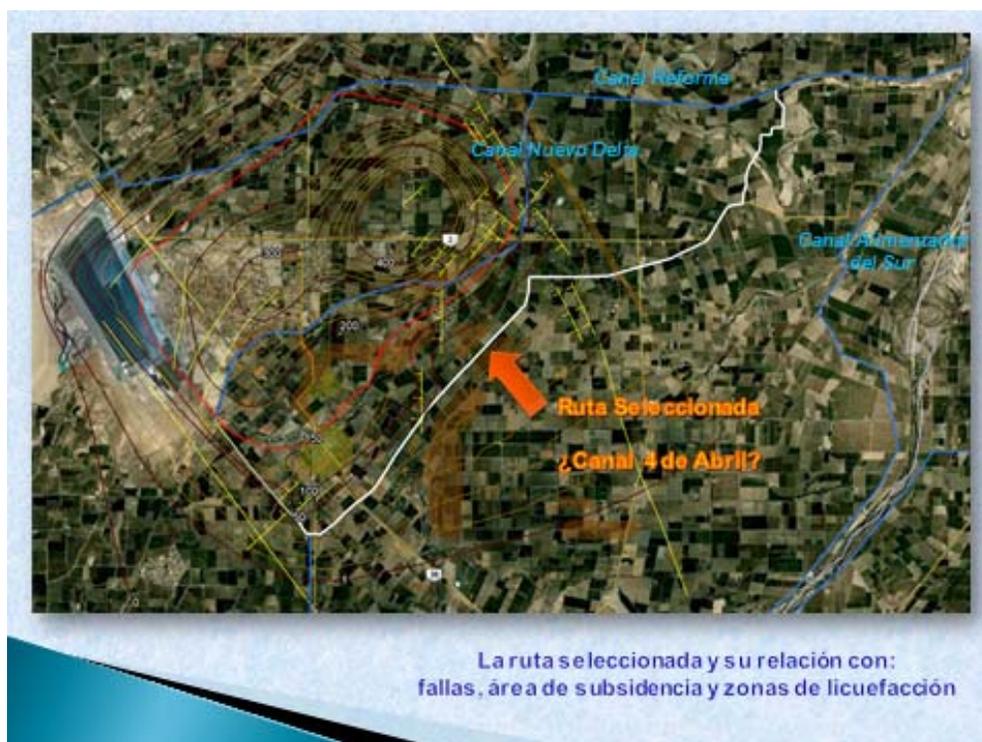
Figure 12. Route of new April 4 canal, showing faults, subsidence, and liquefaction zones.

The damaged Nuevo Delta Canal traversed multiple fault lines and liquefaction zones. Plus, it fell within zones of anticipated subsidence due to groundwater extractions (without recharge) from an adjacent geothermal field.

A design feasibility contract was provided by CONAGUA to Ingeniería Dennis of Mexicali, with the Cal Poly ITRC as a sub-contractor. Over thirty different replacement routes were analyzed and compared in terms of economics, right-of-way acquisitions, road crossings, topography, costs, available pressure, command area, and ability to enhance existing water delivery service. These considerations were overlaid on the maps of subsidence, liquefaction, and faults. The final route of the replacement canal, called "April 4", is shown in Figure 12.

1. The soil will be over-excavated, filled with compacted soil, and then the cross section for the new canal will be cut from the compacted soil.
2. The canal embankments, and the "footing" of the canal itself will be kept dry by preventing moisture from entering from above and below. The two solutions will be:

- a. The canal will be lined with a geomembrane to prevent seepage from "above". That geomembrane is equipped with a fuzzy material on its surface so that concrete will adhere to it. Concrete will be applied with a 3" thickness over the geomembrane. The concrete will provide mechanical protection from cleaning operations and other physical damage that might occur.

- b. A tile drain will be installed approximately 6' below the bottom of the canal, and to the side, to help lower the water table immediately under the canal. This will help minimize moisture from entering the embankment from below, and will possibly provide a more stable footing for the whole structure.
